## The recovery of a Fairey Barracuda from the Solent off the former RNAS Daedalus

**Abstract:** During survey work in 2018, the extant remains of a Fairey Barracuda—subsequently presumed to be Fairey built LS473, recorded as lost during take-off—were discovered submerged off the former Royal Naval Air Station (RNAS) Lee-on-Solent, HMS *Daedalus*. Widely used, the Barracuda was the first all-aluminium high-winged monoplane of the Royal Navy's Fleet Air Arm, but no surviving complete example of this aircraft exist.

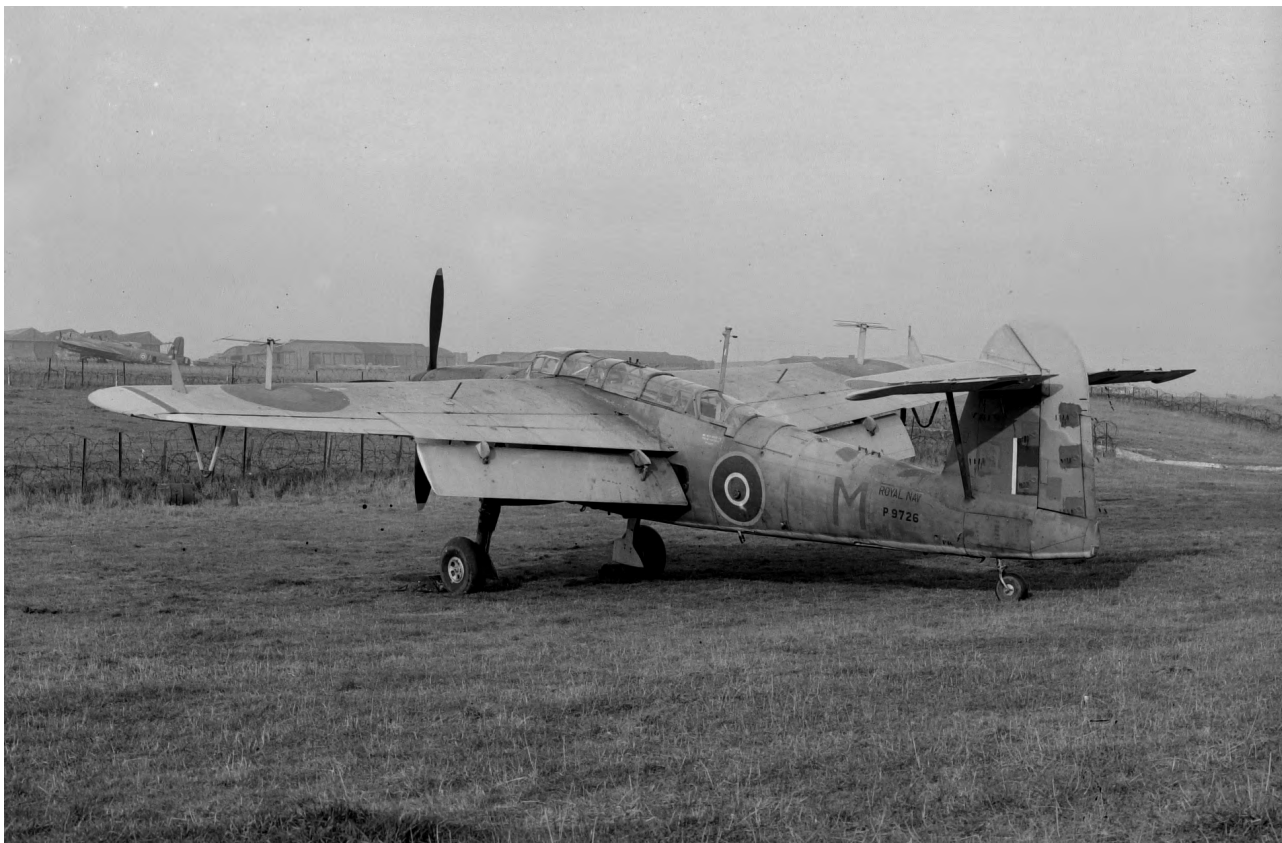
Figure 16.1. Fairey Barracuda Mk. II. Copyright TNA.

This paper reports on the recovery of a Mk II Fairey Barracuda (Figure 16.1) from the sea close to the end of the runway at the former Royal Navy Air Station (RNAS) Daedalus in Hampshire, England. The discovery of the extant remains of an aircraft in a shallow marine environment, and its subsequent excavation and recovery under the direction of professional marine archaeologists, is considered a rare opportunity within the UK. Research into recorded losses produced two possible candidate aircraft. These were being flown as training flights with just the pilots onboard, neither of which resulted in a fatality, following their ditching into the sea on take-off.

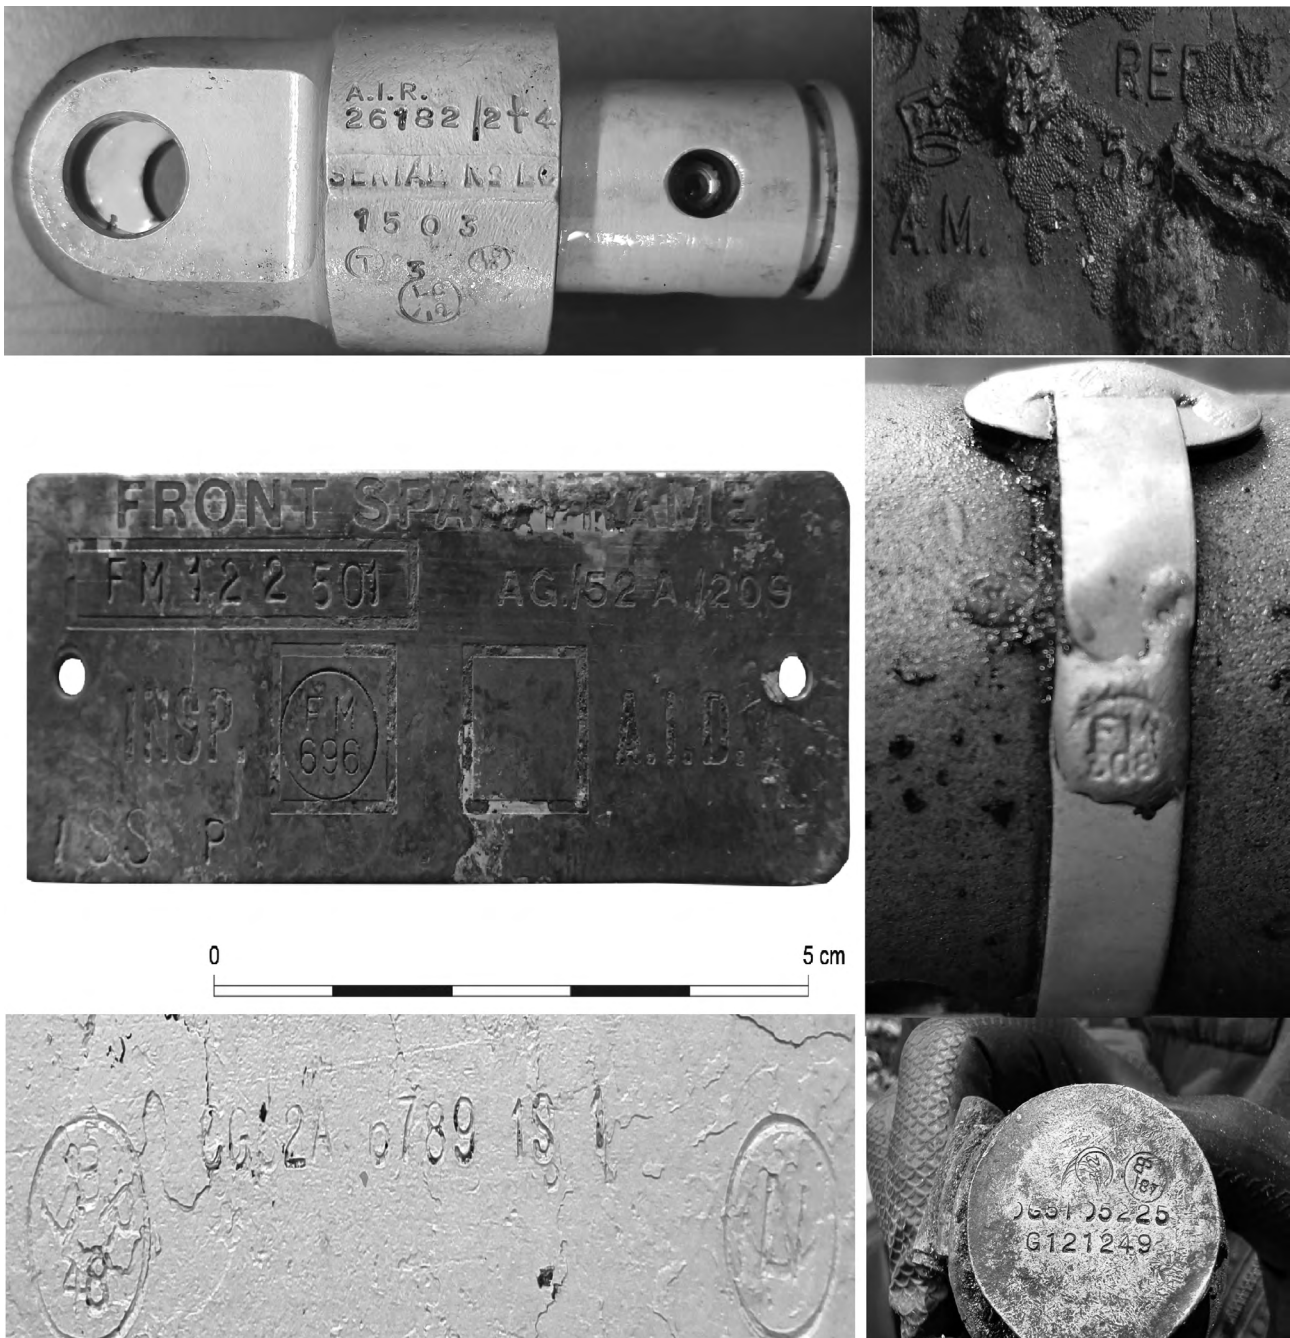
**Figure 16.3.** (Top left) AM embossed on electrical component. (Top right) Lockheed Precision Parts hydraulic component. (Centre left) Examples of Fairey inspection stamp with drawing and part numbers on front spar frame. (Centre right) Fairey Aviation brass hook and eye band with stamped solder. (Bottom left) Bolton Paul inspection stamp with issue one stamp next to drawing number. (Bottom right) Bolton Paul additional or super numary numbers. All images copyright Wessex Archaeology.

The different manufacturers also used different forms of subassembly and part identification tags and modification or 'Mod' plates (Figure 16.3, centre left) to identify the different sub-assemblies of the aircraft, and the plans those sections were built off. Plans went through multiple iterations in some cases, with parts receiving corresponding stamps to indicate which plan version they were built to, such as this Boulton Paul stamped, issue one example (Figure 16.3, bottom left). Fairey Aviation used a system of brass hook and eye clips or bands on the airframe tubes (Figure 16.3, centre right); they also stamped the solder sealing these bands. Unfortunately, most have corroded away with their immersion. Boulton

and Paul used a system of a plain metal band with a folded-over join, and stamped parts with their manufactures code. Boulton and Paul were also known for adding additional or supernumerary part numbers, as well as the standard drawing numbers (Figure 16.3, bottom right). There is also currently one example of a tag which appears to have a month and year stamp on it (Figure 16.4, top left), the visible number being too long to be a drawing number reference. Blackburn initially was thought to have been the only manufacturer of the Barracuda to use ink-stamps in their quality control system (Figure 16.4, top right),

The Solent wreck has in part started to answer this question on the basis of its producing, so far, parts with stamps from three of the four manufactures of the aircraft, along with Air Ministry (AM) (Figure 16.3, top left), Aircraft Standard (AS) or Aircraft General Standard (AGS) marks. These latter two were general standardised parts with no relation to a specific aircraft type. The exception here was the Air Ministry Section 26 parts, which were airframe and type-specific, with 26BT being the designated code for the Barracuda (Robertson 1983: 40). However, these were only present on the packaging holding the part, rather the part itself, with the relevant Fairey drawing number being stamped onto the part, along with any inspection stamps (Will Gibbs 2023, personal communication). Currently, no parts bearing this code have been identified.

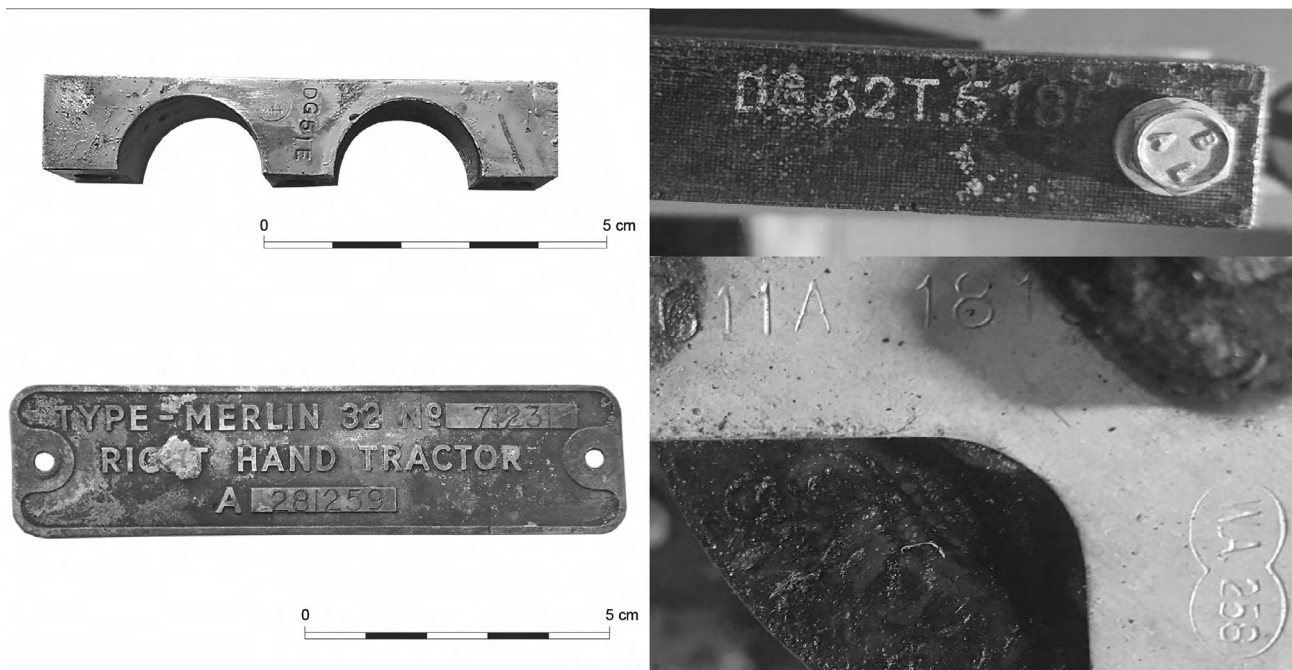
**Figure 16.5. (Top left) Boulton and Paul stamped pipe clip. (Top right) Tufnol block for holding hydraulic pipes with ink stamp from the Solent wreck. (Bottom left) Rolls Royce Merlin 32 engine plate. (Bottom right) Westland quality control stamp and part drawing number on cockpit control arm. All images copyright Wessex Archaeology.**

Research into the recovered engine plate (Figure 16.5, bottom left) received a response from the Rolls Royce Heritage Centre which also appears to confirm the aircraft as LS473. They report engine 71231 was a Merlin 32 built 8 October 1943 and despatched to Fairey at Stockport on 13 October 1943. It was one of 280 Merlin 32 built under Air Ministry Order C/ENG/426/C.28(a) and delivered between 11 September 1943 and 17 December 1943. The 281259 number is the Air Ministry identification for the engine. LS473 was factory-released on 24 November 1943 and lost on 6 January 1944. As BV739 was built in July 1943 and lost at the end of September 1943 it is highly unlikely to have been fitted with engine number

71231. Also visible on the back of this plate is its Rolls Royce part number. The caveat to this is the possibility the engine fitted to the aircraft was replaced or sent onto a maintenance unit and not accurately recorded. Though this seems unlikely, de la Bédoyère (2001: 42) cites two examples of the convoluted histories of Rolls Royce engines, with engines being built after aircraft were in service or surviving when aircraft were lost, due to the exchanging out of engines for overhauling.

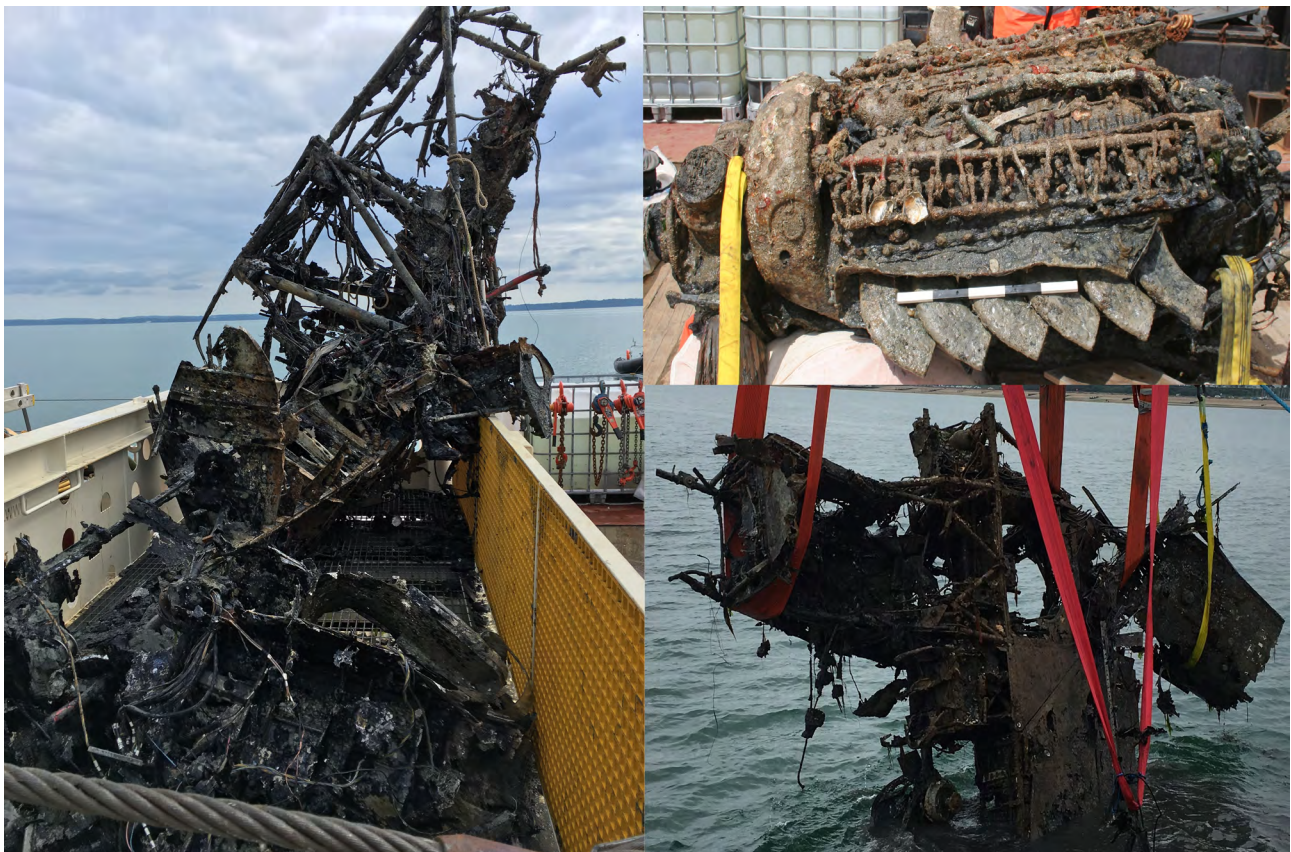
**Figure 16.6.** (Left) Pilot's cockpit, Observer's cockpit, and wing stubs following recovery with subsea basket. (Right, top) Rolls Royce Merlin 32 engine following separation from airframe and recovery. (Right, bottom) Aircraft during initial lift attempt. All images copyright Wessex Archaeology.

In general, the inability to recover the Barracuda fully intact (Figure 16.6) demonstrates the vulnerability of submerged aircraft remains, particularly those in locations with strong tides, currents, changes in sediment levels and heightened human activity. The variable survival of parts of the wreck shows that if these artefacts remain buried within stable seabed sediments and are not disturbed, they may survive long term. As reported by Macleod (2016), sheet aluminium does not attract marine growth in the same way iron and steel do. Nevertheless, when exposed to tidal streams, currents, abrasion through sediment movement and highly destructive seabed activity, these wrecks are at high risk and become highly fragile very quickly (North and Macleod 1987; Macleod 2006).
