Climate change impact assessment on shipwreck sites in Ireland

Sandra Henry, Edward Pollard, Gerard Dooley, Kieran Craven, Robert Shaw, Anthony Corns, James Barry, Karl Brady, Connie Kelleher and Fionnbarr Moore

Abstract: In Ireland, the CHERISH project has investigated the impacts of climate change on wreck sites exposed to different environmental conditions. Remote sensing and archaeological recording methodologies created substantive site records, baseline and monitoring datasets. Maritime archaeologists, geologists, divers, surveyors and geophysicists worked together, providing a range of expertise for data collection, analysis and appraisal. The incorporation of previous site records made it possible to assess change and site formation processes for periods longer than the six-year course of the project. The CHERISH project looked at a number of wrecks from three different locations and environments, including unidentified wooden intertidal wreck sites at North Bull Island, Dublin, which are being impacted and damaged by storm activity on an annual basis; the schooner *Sunbeam* located at Rossbeigh Strand, County Kerry, which has suffered severe damage due to storms in recen

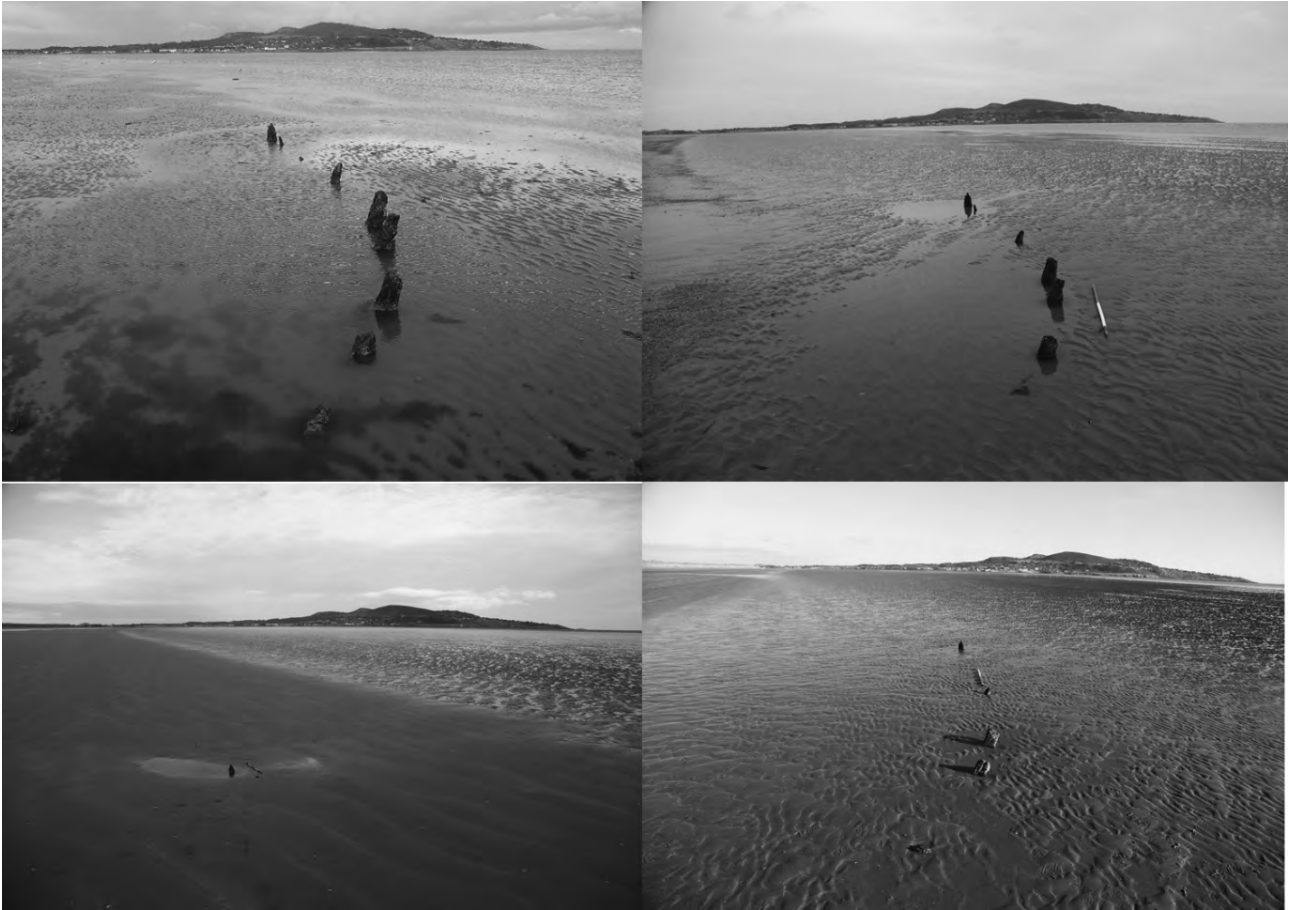
Prior to CHERISH, the UAU surveyed Wreck 1 (W01131 in the WIID) between 2004 and 2006; the vessel was recorded as exposed for 9.30 m by 3.35 m with clinker overlapping planks and 14 oak futtocks (Brady 2008: 236–237). Photographs showed a wreck on the sand flat in a pool larger than the extent of the exposed wooden futtocks. Further images from March 2015 held by the UAU show a wreck in a smaller pool, as there are three futtocks above

Figure 17.1. North Bull Island Wreck 1. Clockwise from top left: 2 September 2019; 8 January 2020; 20 January 2020 (after Storm Brendan, which occurred on 13 January 2020); and 11 March 2020. Photographs taken looking northeast. Copyright Discovery programme/CHERISH project.

water level in the pool on the surrounding sand ripples of the sand flat. The sand level must have been higher, as only two timbers were exposed on the northern side, as opposed to at least nine in the earlier survey. The largest extent during CHERISH surveys was 7.92 m with only one side of exposed futtocks visible. However, the magnetometer survey showed a magnetic disturbance around Wreck 1 of about 12 m long and 5 m wide. Wreck 1 (Figure 17.1) was recorded in September 2019 on the sand flat around 20–30 m seaward from the sloping beach which leads from the sand flats to the sand dunes. Ten timbers were recorded initially, although after the storms in January, this number had reduced to six, and by the last visit in March, there was only one timber visible. The beach profile from the sand cliff at the HWM across the sloping beach and over the wreck in January shows the wreck only 7 m from the sloping beach and the smoothing of the sloping profile of the beach. Wreck 1's length of around 12 m suggests a sloop- or yawl-sized vessel.

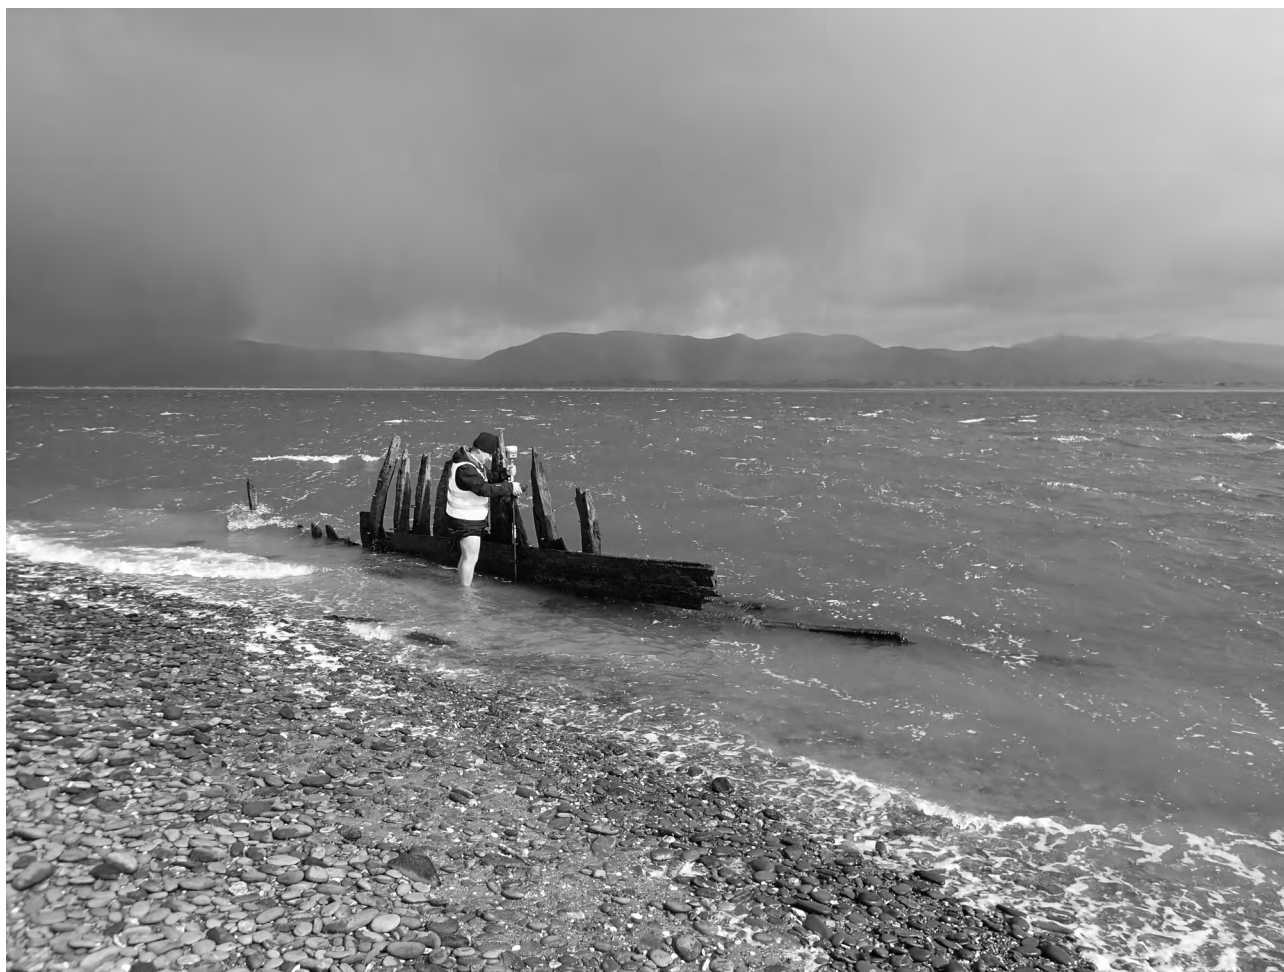
A wider search on 10 October 2018, which involved a walkover survey of the entire extent of the spit, found a portion of the lower hull of the *Sunbeam* (Figure 17.3) at the northern tip of Rossbeigh Spit, at the entrance to Castlemaine Harbour. This is 2.4 km northeast of its last recorded position, and it had therefore moved farther north along the spit for at least 2 km and was washed about 700 m into the mouth of the channel. Not surprisingly, the wreck had been badly damaged and was now in poor condition, with only about 10 m of one side remaining and 2 m in height of hull structure surviving above the seabed. The full extent of this remaining part of the hull section could not be fully surveyed due to being submerged within the channel. It lay just beyond the low water mark in an area of sand with patches of pebbles. Marine growth

Figure 17.3. CHERISH project staff recording *Sunbeam* in 2019. Copyright Discovery programme/CHERISH project.

(barnacles, mussels and sea lettuce) flourished on the wreck in its new location; this indicated the wreck was exposed near the low water mark for some time. Following another inspection in April 2019, marine growth on the ship timbers was observed to have decreased to mostly barnacles and sea lettuce, possibly indicating continuous levels of sand abrasion was limiting marine growth. The wreck had continued to deteriorate; copper alloy nails and wooden dowels which originally held the hull planks together were very exposed. A beach profile was carried out; this procedure was repeated in May 2022 when the substrate was found to be sandy again, probably indicating longshore drift and accretion of sand. Only five ribs remained above the water line, with six of the previously recorded ribs impacted and lowered to the remaining planking height. Sea lettuce growth had increased to cover the protruding ribs, along with bladder wrack on lower parts more permanently underwater. Beach profiling was undertaken at the northern end of Rossbeigh Spit in 2019 and 2022, revealing several metres of erosion of the island towards landward.
