## The Residential Complex

### 4.1. The Residential Structure

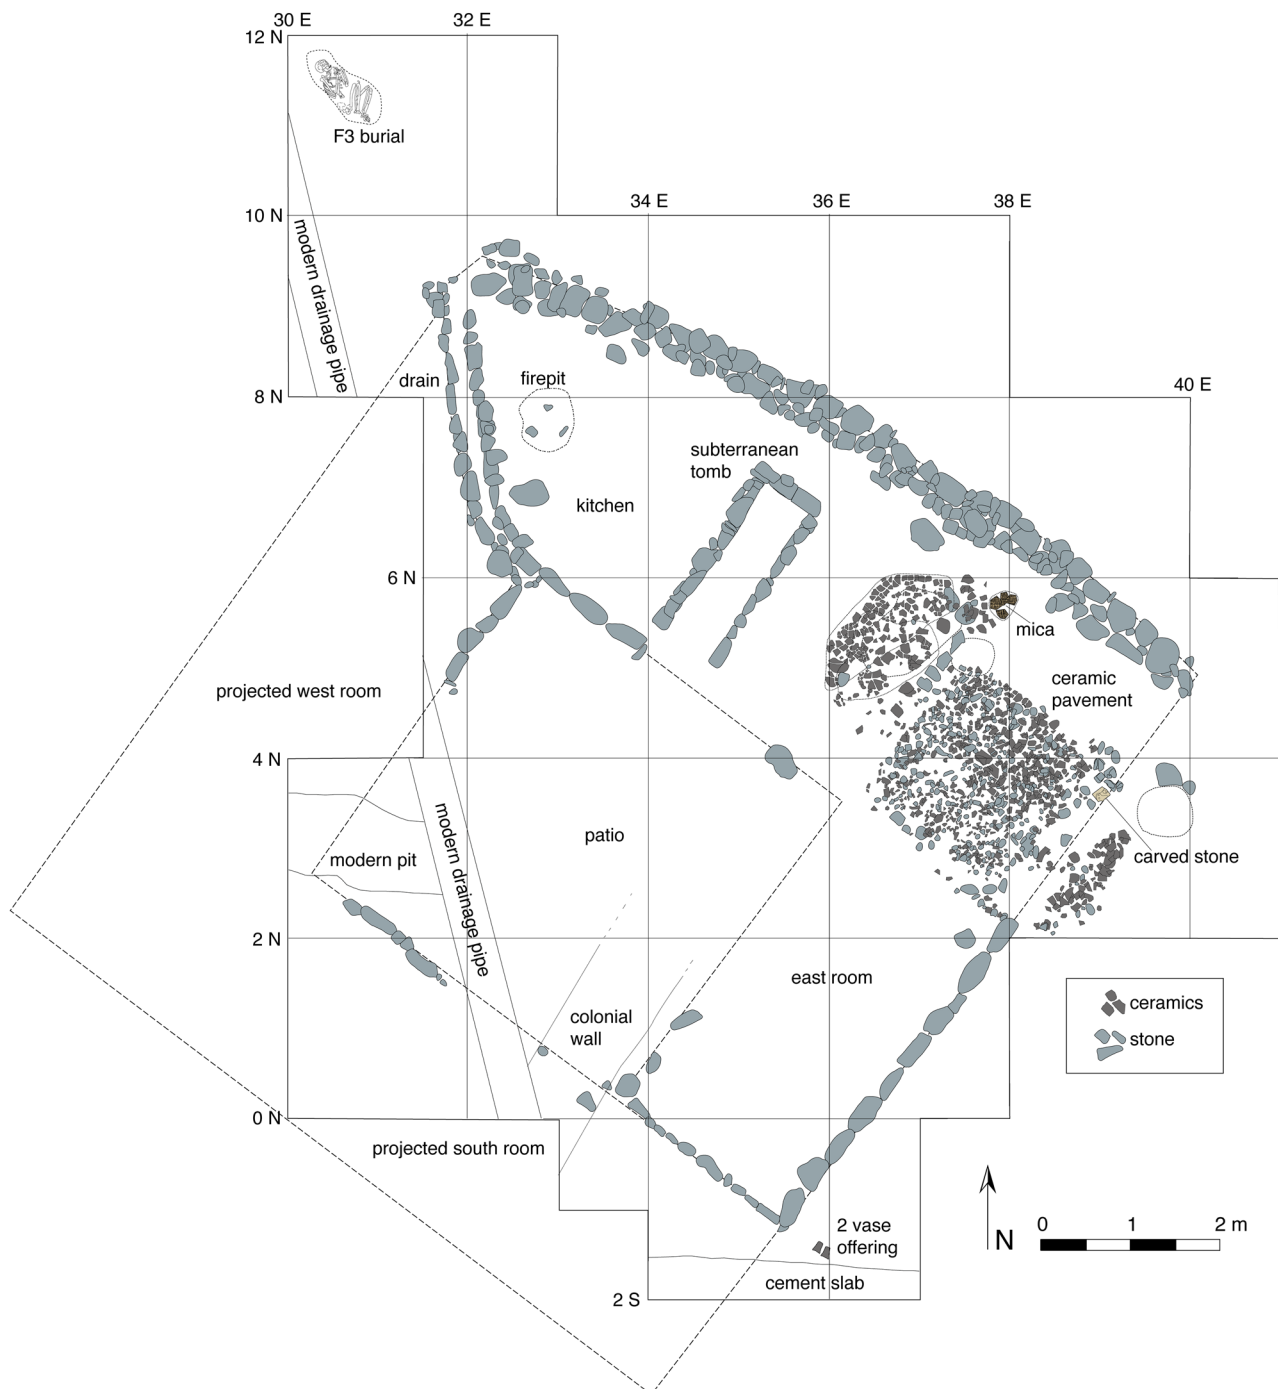
**Figure 4.2. Map of the excavated house and associated features.**

The prehispanic house that we excavated in Ejutla was defined by a foundation of stones that demarcated several rooms around a small patio (Figure 4.2). These basal stones

Partially preserved foundation walls of flattened and shaped rectangular stones defined the edges of the residence's small patio. The patio enclosed an area of 4.5 × 4.3 m and was oriented approximately 35° east of north. The best-preserved foundation walls were in the northwestern corner of the patio, where a stone-lined drain allowed water to flow from the patio to beyond the northwestern edge of the residential structure (Figure 4.5). Roughly shaped stones formed the sides of the drain, and smaller flat stones lined the bottom. A small room on the east side of the patio was approximately 2.5 × 4.3 m in size. A foundation of large, roughly formed rectangular stones formed the eastern, exterior wall of the room, while a line of much smaller and thinner rectangular stones marked the southern edge of the room (Figure 4.6). Although only a few foundation stones in the northern and western (interior) walls of the east room were preserved, they appear to have defined a small, covered living space that was entered from the patio. During the excavations we also uncovered an offering of two small, carved ceramic vases that had been placed outside the corner of the east room, most likely as part of a dedicatory ritual during construction of the house (Figure 4.7, see also Figure 4.2).

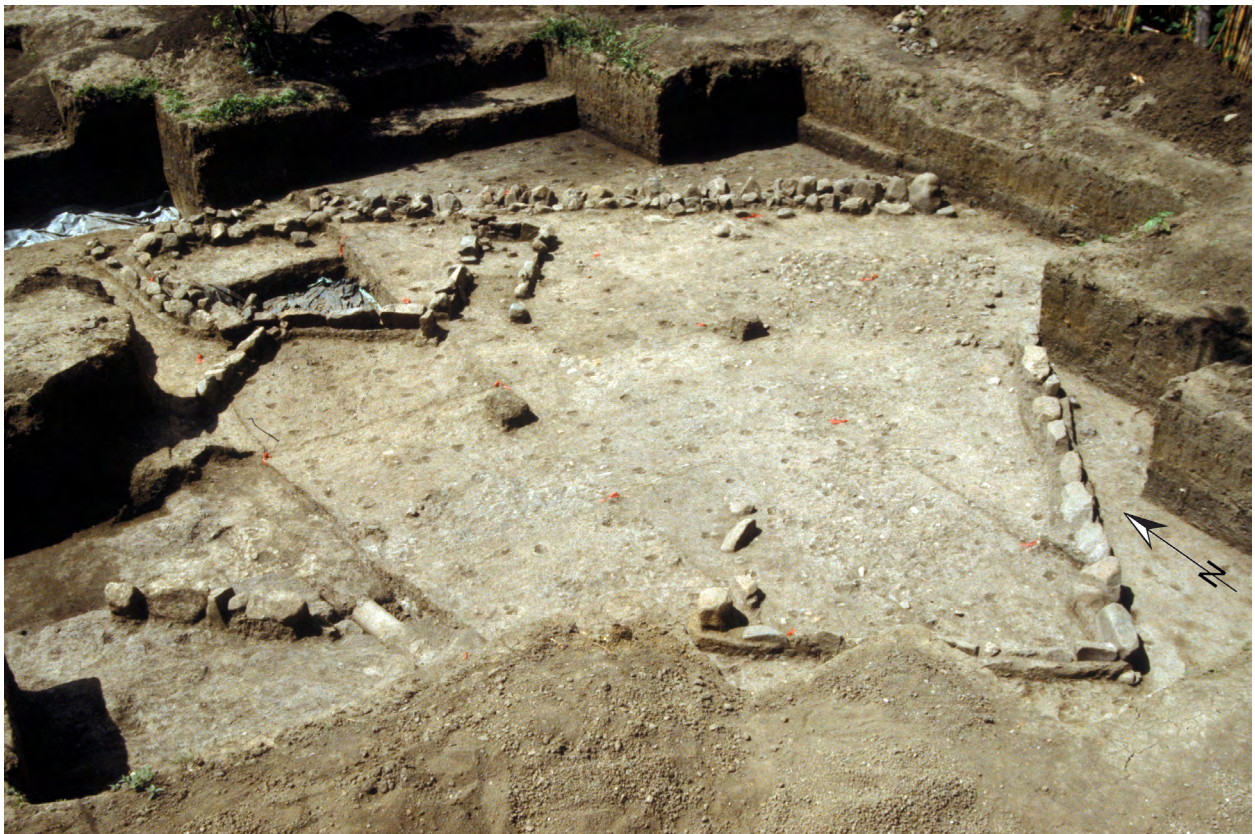
**Figure 4.4.** The patio and north and east rooms of the prehispanic structure.

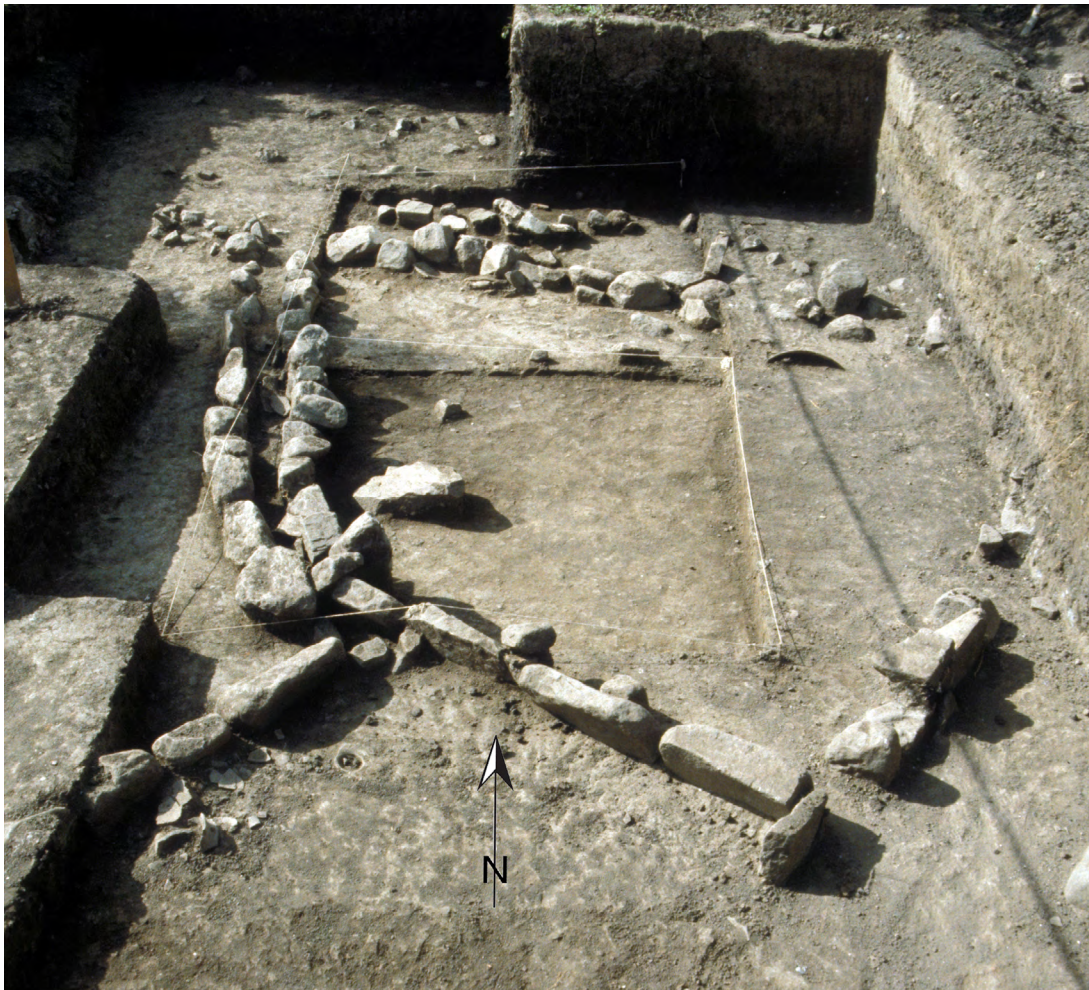
Figure 4.5. The stone-lined drain in the northwest corner of the patio.

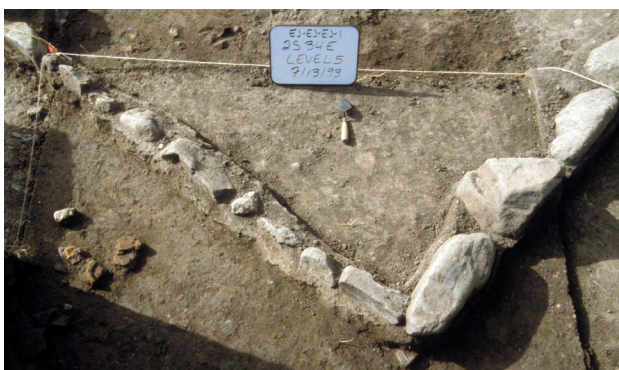
Figure 4.6. The stone foundations of the eastern and southern walls of the east room.

Although rooms on the southern and western sides of the patio were not confirmed by the excavations, the small stones in the foundation of the southern wall of the east room are not substantial enough to have sustained a thick adobe wall, compared to the much larger, roughly shaped stones in the foundation of the exterior eastern wall (see Figure 4.6). The stones in the southern and western walls of the patio also are smaller than those in the exterior structure walls on the north and the east. In addition, there were many fewer ceramics and other debris beyond the southern and western edges of the patio than there were along the eastern and northern edges of the structure, where middens built up over time outside the walls of the house (Figure 4.11). The per-unit quantity of artifacts collected from the projected rooms on the southern and western sides of the patio were much more comparable to the interior areas of the house than to the exterior midden areas on the north and east. Based on these observations, we strongly suspect that there were rooms on the south and west sides of this complex that were destroyed by subsequent, post-use activities. If rooms on the southern

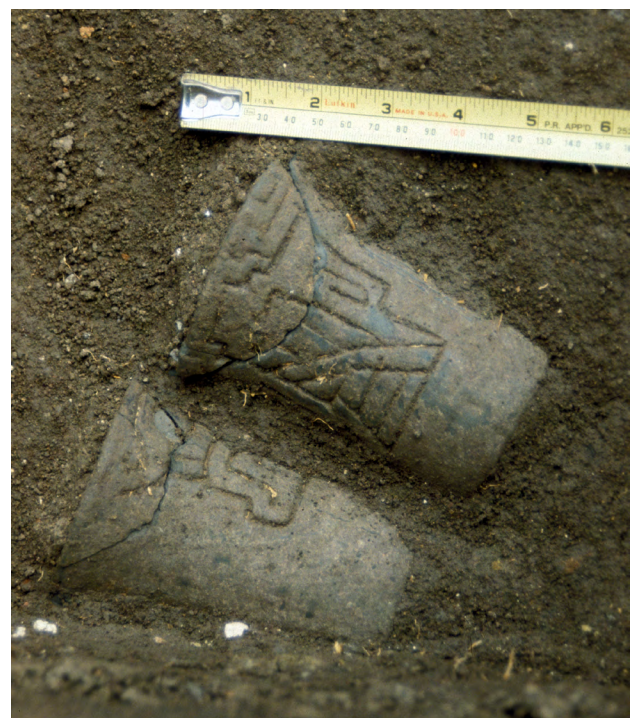
Figure 4.7. Offering of two carved ceramic vases outside the southeastern corner of the east room.

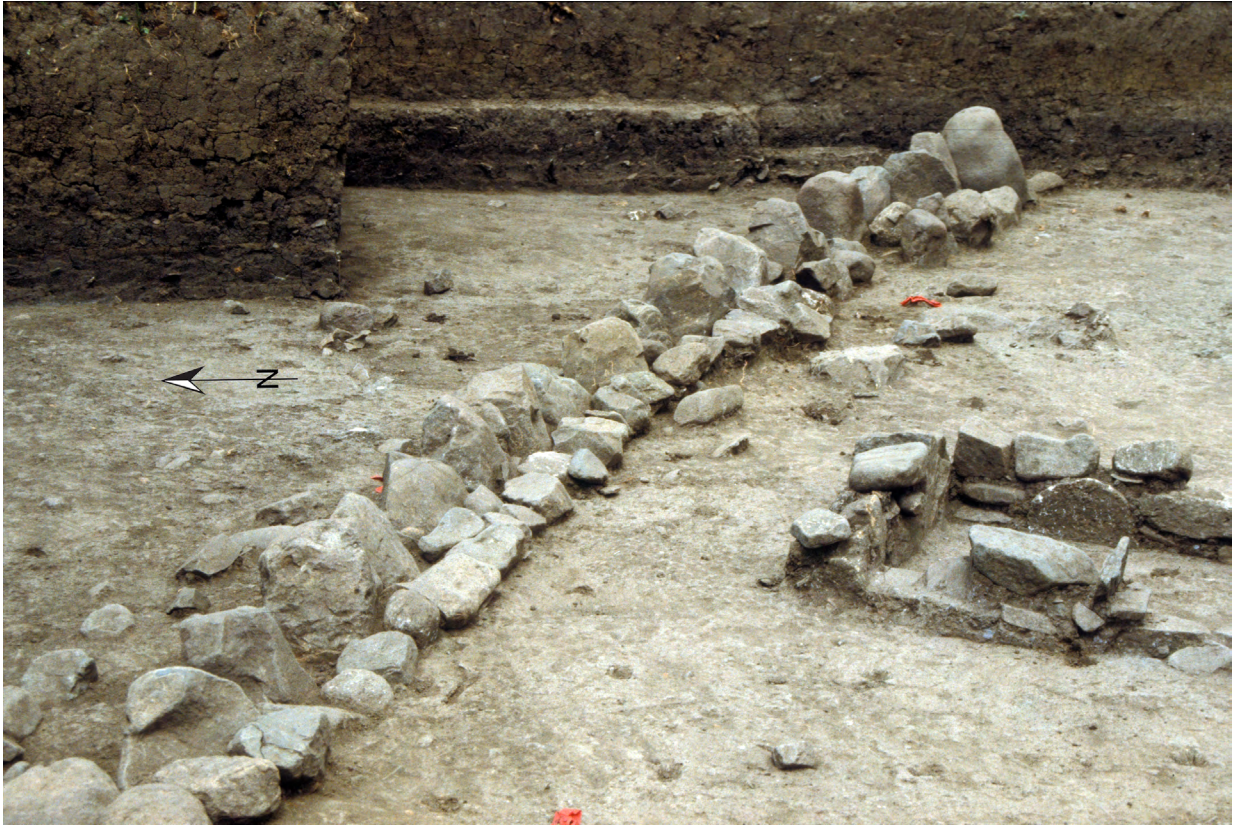
**Figure 4.8.** The north wall of the residential complex (the orange flagging tape marks the corners of 2 × 2 m units).

of the structure was much more substantial, constructed of two parallel rows of much larger roughly shaped and unshaped stones and small boulders that were set deeper into the underlying fill (Figure 4.8). On the west, the stone wall abuts the northern end of the drain from the patio that passes through the room. On the east, the wall ends in line with the exterior foundation wall of the east room. These two walls did not connect, leaving the northern area open on the east. There was no evidence that foundation stones had been removed from this area.

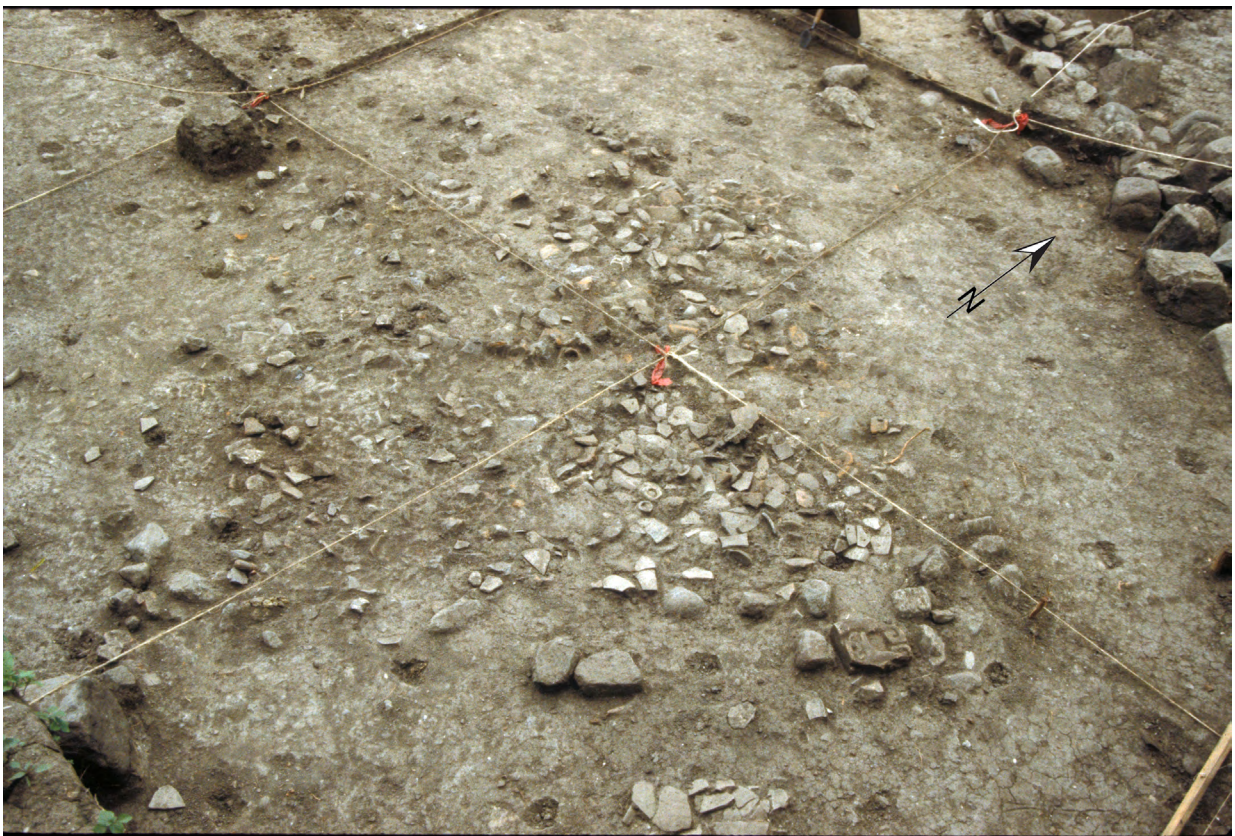
**Figure 4.9.** Top of the ceramic and stone pavement in the eastern part of the north room.

A small stone-lined tomb on the north side of the patio divided the northern space roughly in half. In the western area, between the drain and the tomb, there was evidence of burning and the preparation of food, a possible kitchen area (see Figure 3.14). In the eastern half, there were several superimposed stone and sherd pavements that appear to have been work surfaces (see Figure 4.2). The larger one, approximately  $2 \times 2$  m, was roughly squared and abutted the northern edge of the east room (Figure 4.9). This pavement extended approximately 0.5 m beyond

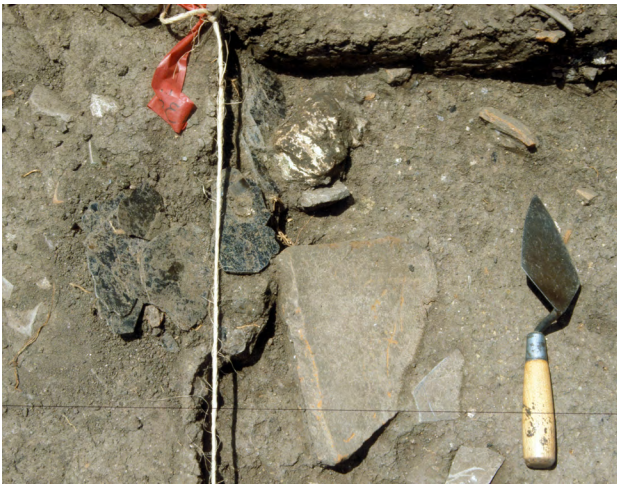
**Figure 4.10.** Large sheets of mica in a small pit near the ceramic pavement in the north room of the structure.

the end of the northern wall of the structure and the edge of the east room. The wall separating this pavement from the room to the south may have been perishable, as the only evidence of a wall here was a partial line of small stones perpendicular to the northern end of the exterior wall of the east room and in line with the northern edge of the patio. Next to the smaller pavement was a shallow pit that contained several large, thick pieces of mica that were stored as raw material (Figure 4.10).

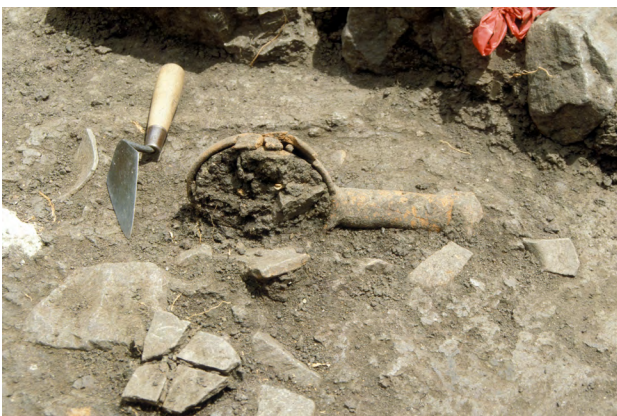
**Figure 4.11.** Broken *sahumador* (incense burner) and other trash on the north side of the residential complex.
