## **The archaeology of ships and boats**

## Boats from bogs in Arctic Norway: depositional contexts and explanatory frameworks in the Late Iron Age and Mediaeval period

Stephen Wickler

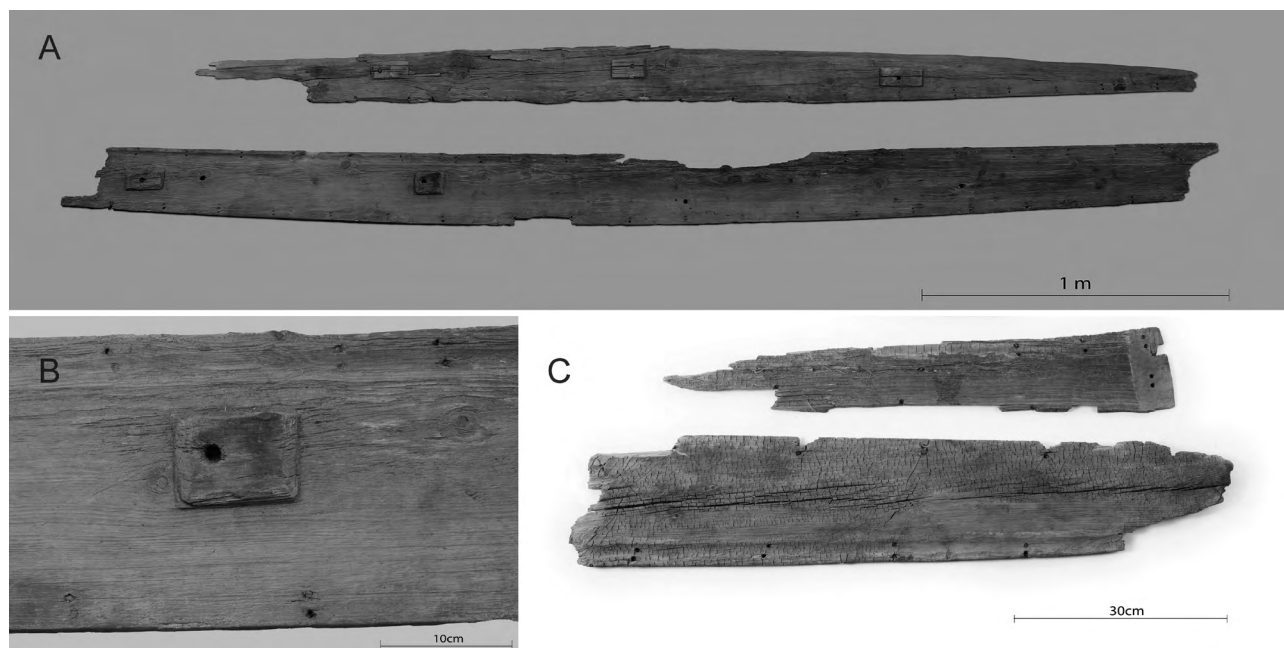
**Figure 9.4. Grunnfarnes boat planks: A) the two largest plank fragments; B) closeup view of a cleat with treenail hole and paired stitching holes on the largest plank; C) smaller plank fragments, including a scarf with two pairs of stitching holes. Photos by Adnan Icgic, Arctic University Museum of Norway and used with permission.**

The three main plank fragments are 1.9, 3.3 and 3.6 m in length (Figure 9.4A). Plank segments with intact edges range 20.0–23.0 cm in width and 1.0–1.5 cm in thickness. Plank thickness indicates they are from a small boat about 5.0–6.0 metres long. Vertical paired stitching holes 0.5–0.6 cm in diameter and spaced 0.7–1.0 cm apart extend along both plank edges with average distances ranging 15.0–17.5 cm between pairs. Although remains of ‘rope’ were reported in the stitching holes when the planks were found, no definite evidence of this was observed during later examination. However, plant fibres were likely used for stitching. Small wedge-shaped plugs used to hold the thread in place remain in some stitching holes. A concave lap moulding 2.5–3.0 cm wide where caulking was placed is present along the edge of three plank fragments. Rectangular cleats up to 13.0 × 7.5 cm in diameter and 1.5 cm high with single treenail holes *c.* 1.5 cm in diameter for fastening frames are preserved on several planks (Figure 9.4B). The

distance between cleats is *c.* 82.0 cm, and two additional treenail holes without cleats spaced 77.0–85.0 cm apart were used for fastening frames closer to the stem, which did not require cleats. Scarfs are present on three plank fragments. The most complete is 5.2 cm long with two pairs of stitching holes 0.5–0.6 cm in diameter and 0.7 cm apart (Figure 9.4C).

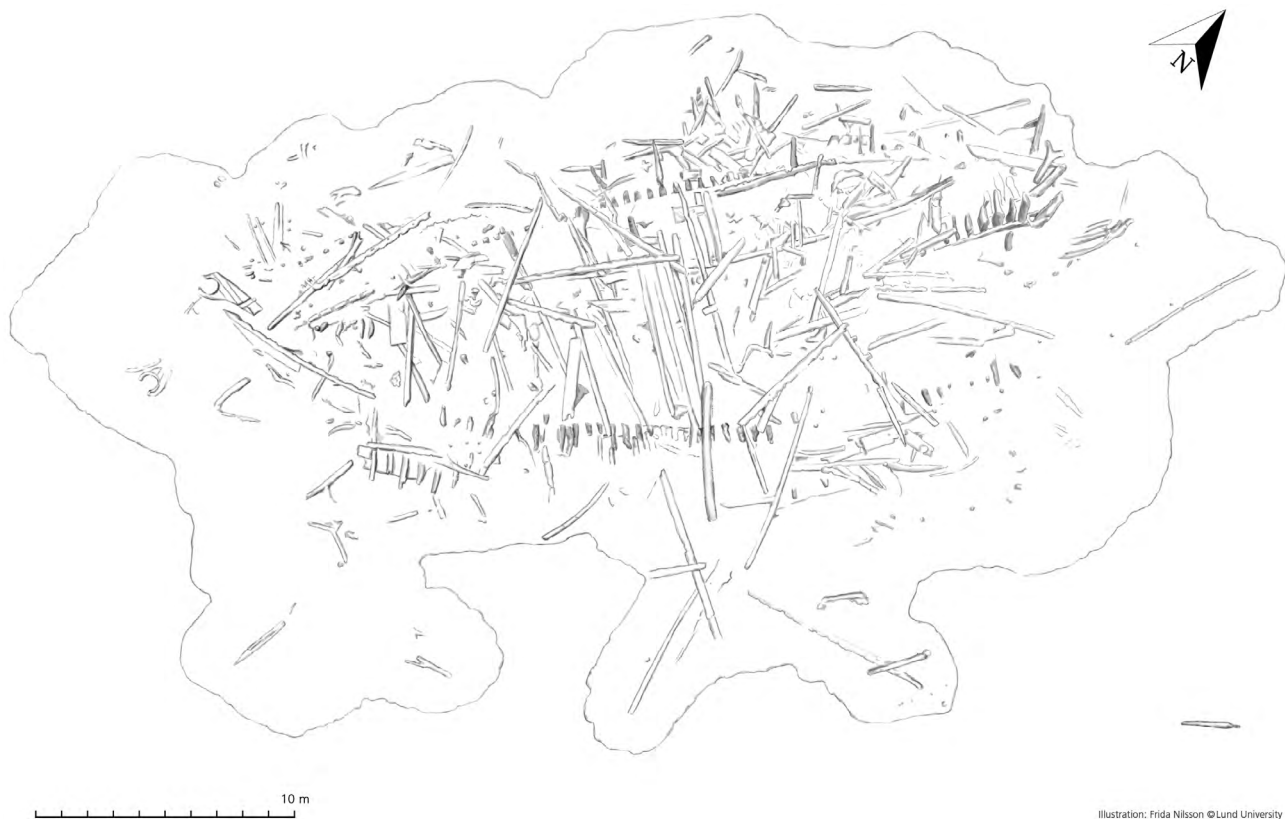
**Figure 10.1.** Site plan of *Gribshunden* shipwreck, derived from photogrammetric model. Illustration by Frida Nilsson, MediaTryck/Lund University.

port quarter suggests an explosion below the waterline, which might have been enough to blast open the hull outright, or might only have sprung planks to permit uncontrolled flooding (Figure 10.1). During the 2022 field campaign, the archaeological team may have discerned the first indirect evidence of this explosion. From the locus of the tiller, two partially deformed lead/iron composite artillery shot both showed flattening and scoring on one side. Perhaps these shot were stored near the source of the explosion, and were flung against the interior of the ship during the event (Jahrehorn 2023).

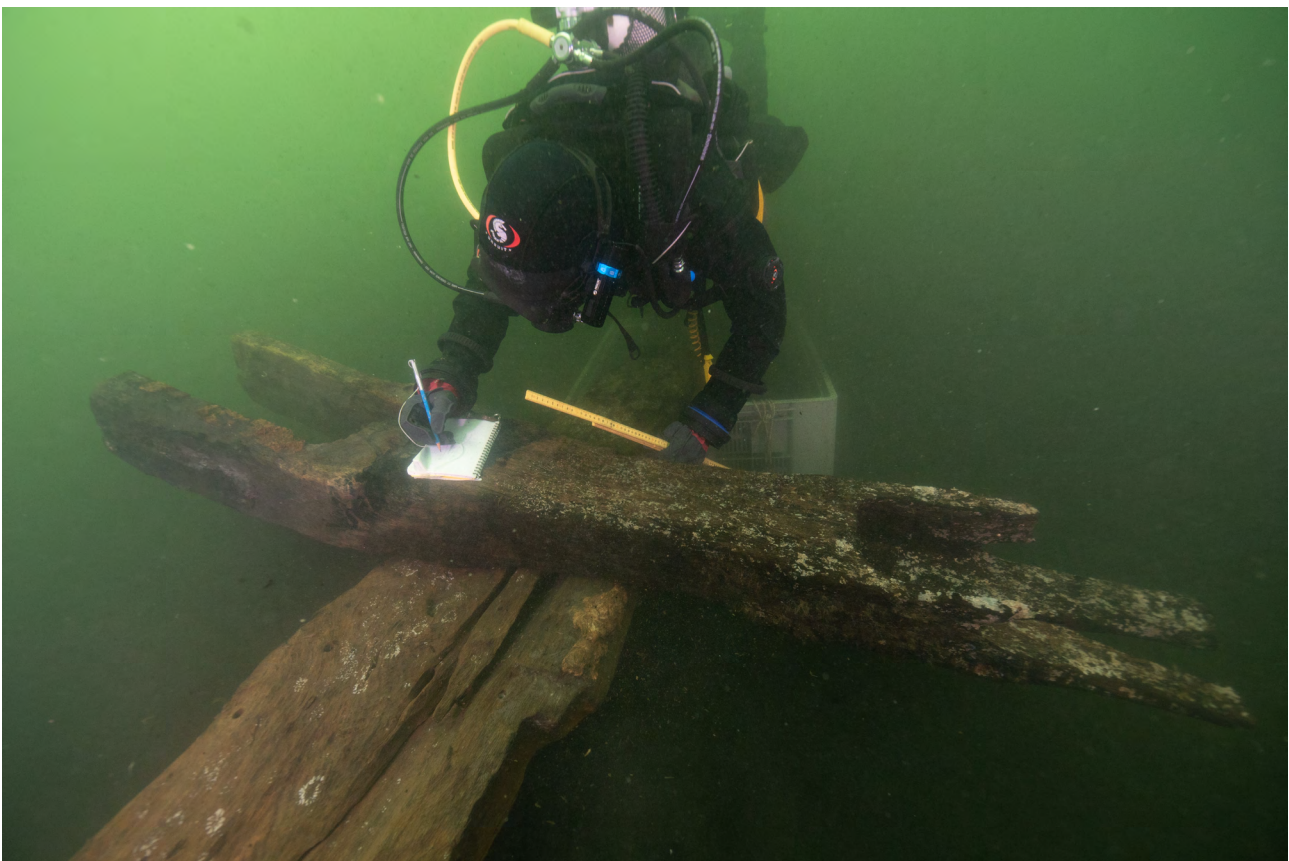
Figure 10.3. The tiller of *Gribshunden*, prepared for photogrammetric modelling underwater prior to recovery. Image by Brett Seymour, *Gribshunden* Project Lund University/Blekinge Museum/Vikingskibsmuseet.

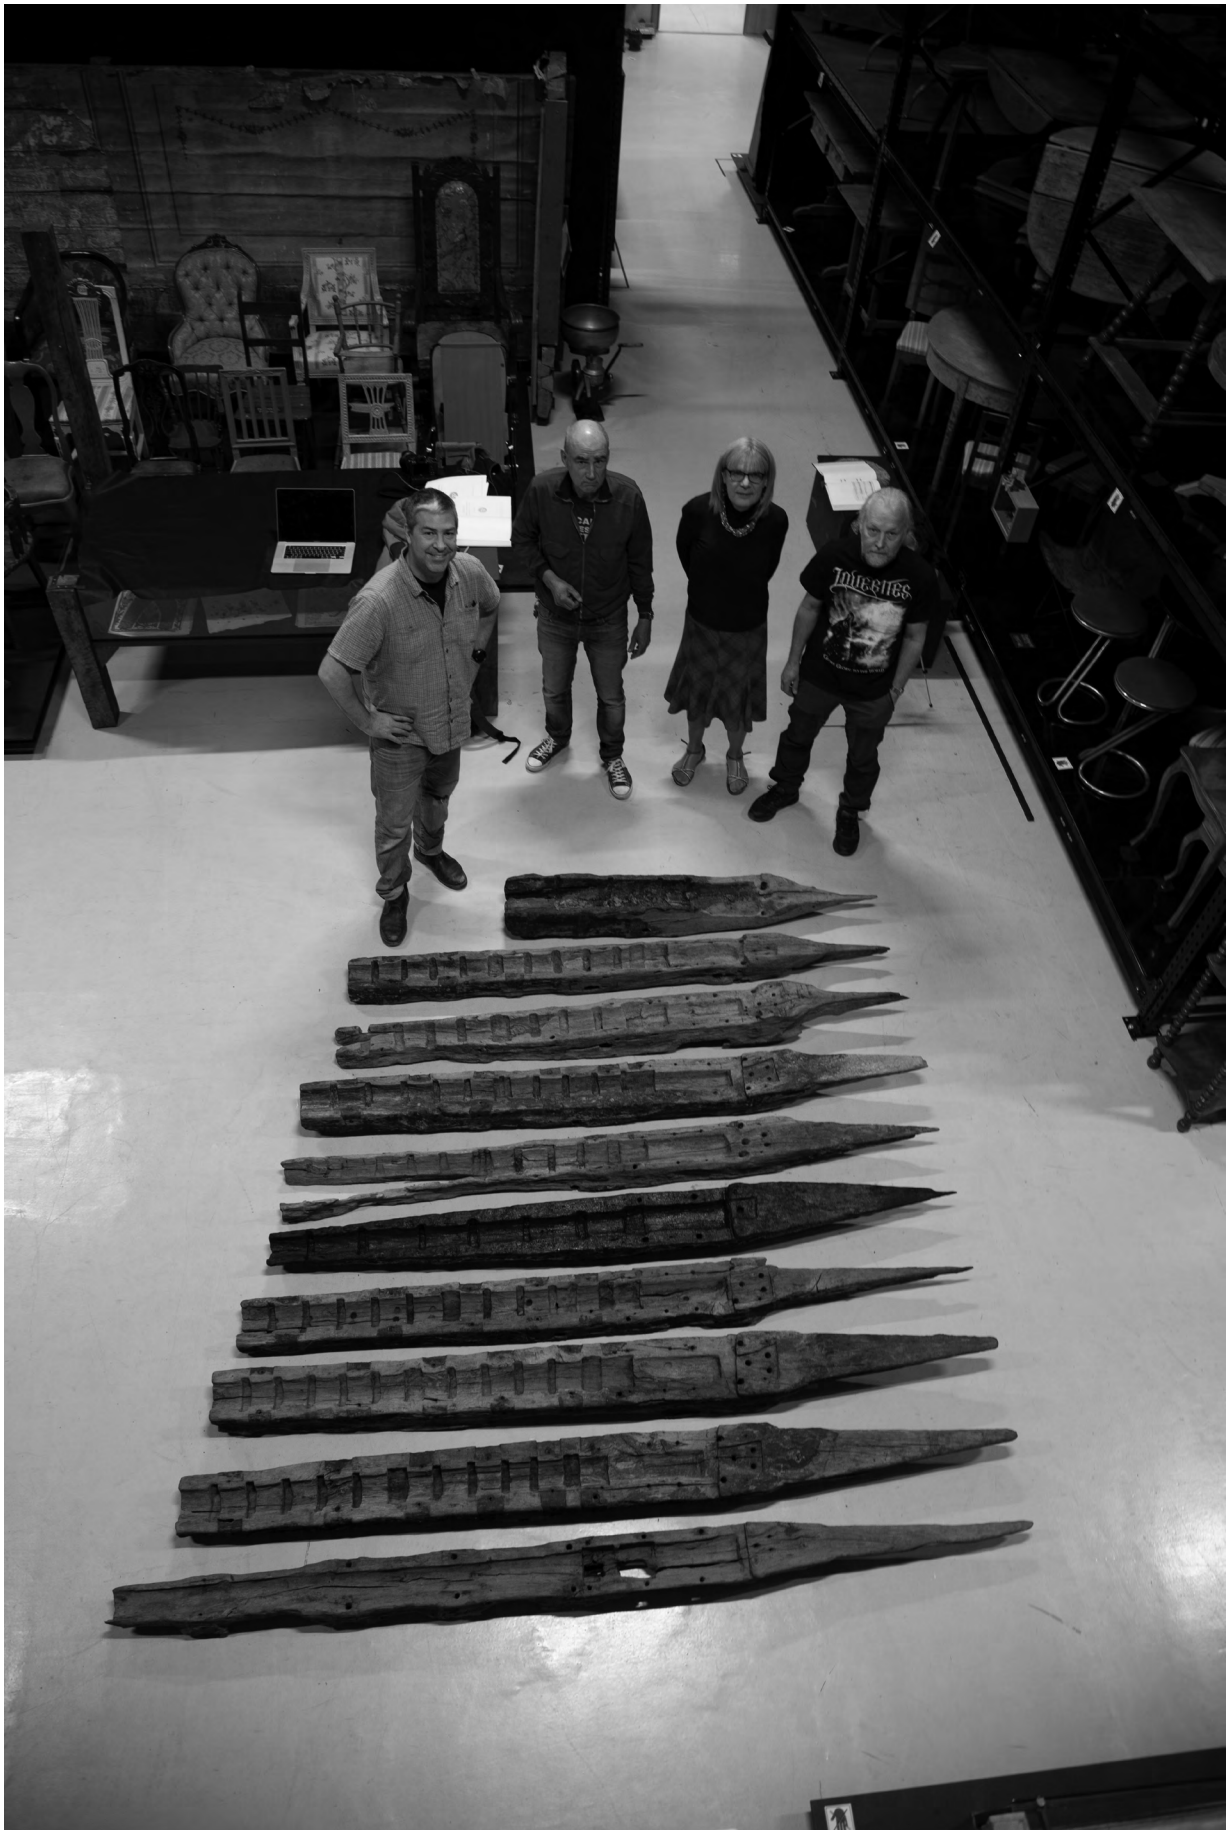
**Figure 10.4.** Ten of the gun beds recovered from *Gribshunden* during operations in 2002 and 2021. Image by Ruth Rynas Brown, *Gribshunden* Project Lund University/Blekinge Museum/Vikingskibsmuseet.

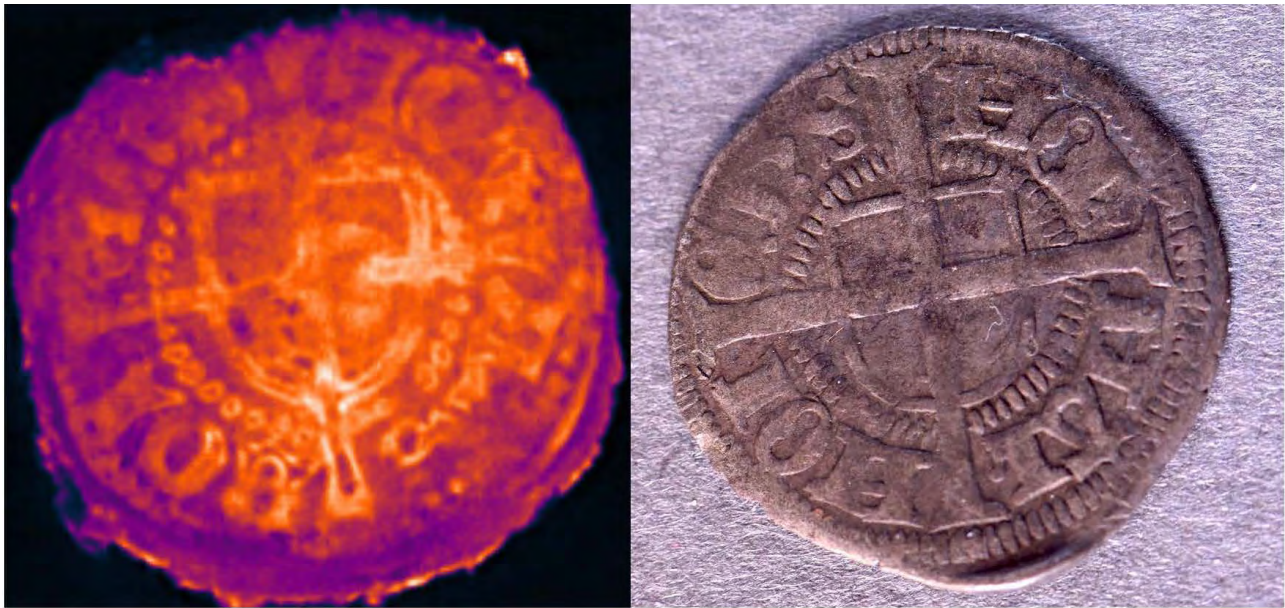
Figure 10.5b. Left: CT image of coin motif from concretion. Image: Gitte Ingvardson, Dirk Muter and Brendan Foley. Right: A similar Danish *hvid* coin from the Blekinge Museum collection, minted in Malmö during King Hans' reign. Image by Brendan Foley, Lund University/Blekinge Museum.

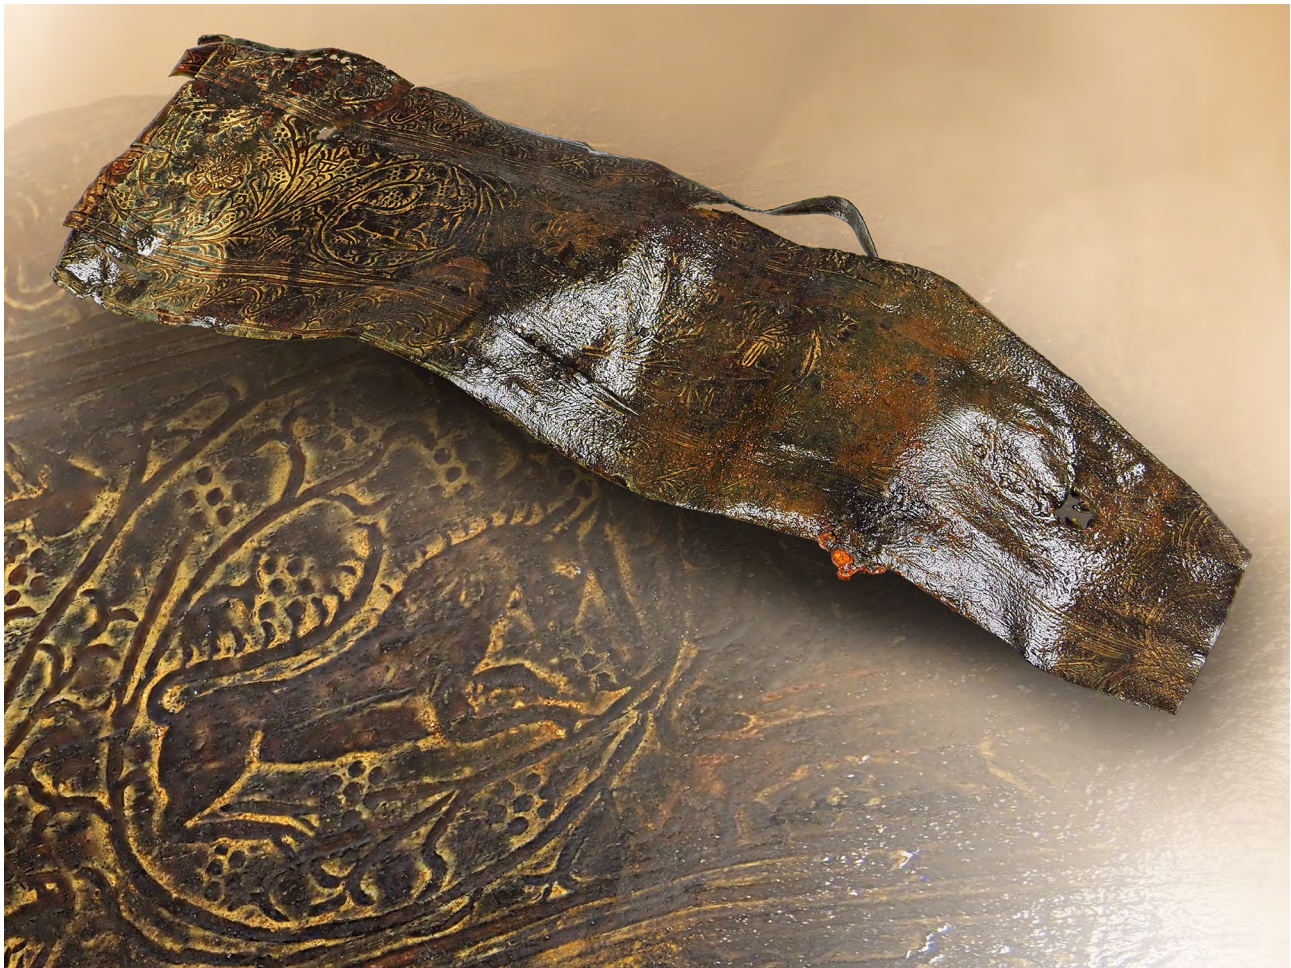
Figure 10.6. The unicorn embossed/printed on two identical birch bark panels with floral and mythical animal motifs recovered from *Gribshunden* in 2021. Image by Åke Nilsson, Blekinge Museum.

Feasting, gambling and gaming, gift-giving and displays of martial prowess surely would have been activities conducted during the Kalmar summit. Hunting, too, might have been pursued by the participants. *Gribshunden* presents some evidence to support this. The 2021 excavation trench produced a number of crossbows and accessories for them, including several arrows of different designs (Foley 2022). Some of these are interpreted as bolts for hunting. While any crossbow could be used for game, some of the most elaborately decorated Mediaeval crossbows in museum collections were the property of princes and used exclusively for hunting. The tillers of these crossbows were richly inlaid and decorated, and their composite prods were often covered with birch bark embossed with patterns and repeating designs. Finds from *Gribshunden* include two birch bark panels measuring 330 × 110 mm, and pressure-printed with identical motifs.<sup>3</sup> The entire motif has not yet been discerned, but floral elements swirl around a unicorn, and several wild animals and birds adorn the perimeters of the panels (Figure 10.6). These panels were recovered from a locus at the edge of the

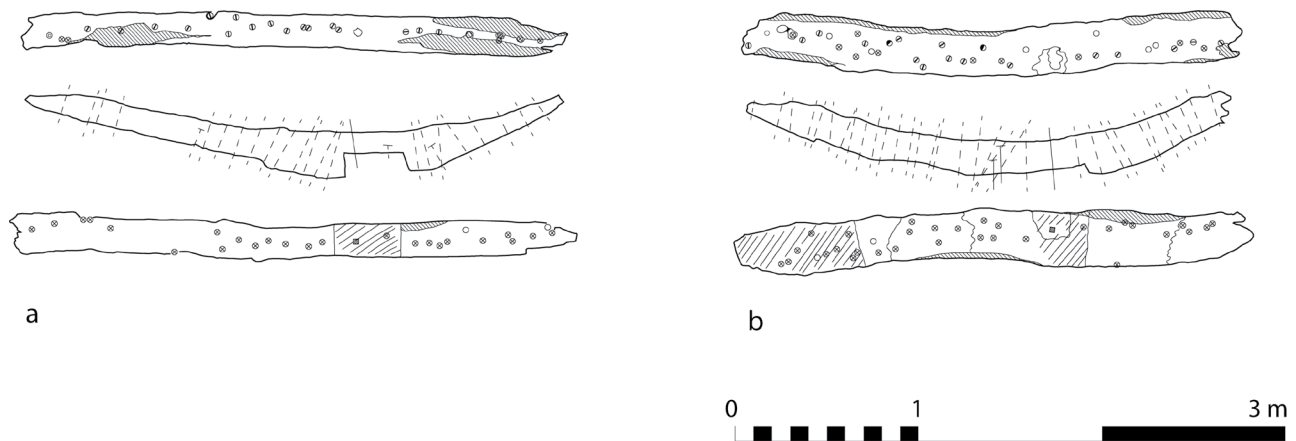
Figure 11.3. Rider 1 (a) and rider 2 (b) from the forward end of the lower hull. Image by S. Mulder, after Kroes 1995.

Two riders (Figure 11.3) were present in the forward end of the lower hull when it was recovered from the seabed. An imprint in the ceiling planks indicated that aft of these two, a third rider might have been present (Koopman and Goudswaard 1991: 1). During excavation, the presence of a third rider was indeed proposed, but the interpretation of one rider was also refuted later when it turned out to be a loose timber from higher up in the ship's construction which had ended up on top of the ceiling planks (Dive report Thijs Maarleveld 19 July 1988; dive report Peter Stassen 30 September 1988). It is unclear as to what extent these statements relate to one another and whether the loose timber is indeed the same as the presumed third rider and/or the cause of the imprint in the ceiling planks.

Structural elements in the forward end of the keel were numbered from aft to front, making the rider closest to the bow rider 2 and the one aft of it rider 1. Rider 1 (Figure 11.3a) is 18 cm sided and 25 cm moulded at its largest extent near the centre and is *c.* 240 cm long. It has a *c.* 34 cm wide and *c.* 13 cm deep notch at the centre of its bottom face, which allows the rider to fit over the keelson. Rider 2 (Figure 11.3b) is situated about 50 cm forward of rider 1. It is 25 cm sided, 20 cm moulded and has an overall length of 265 cm. Rider 2 was notched in the centre of its bottom face too, yet with only a clear indent of *c.* 6 cm on starboard side, again, to make the rider fit over the keelson.

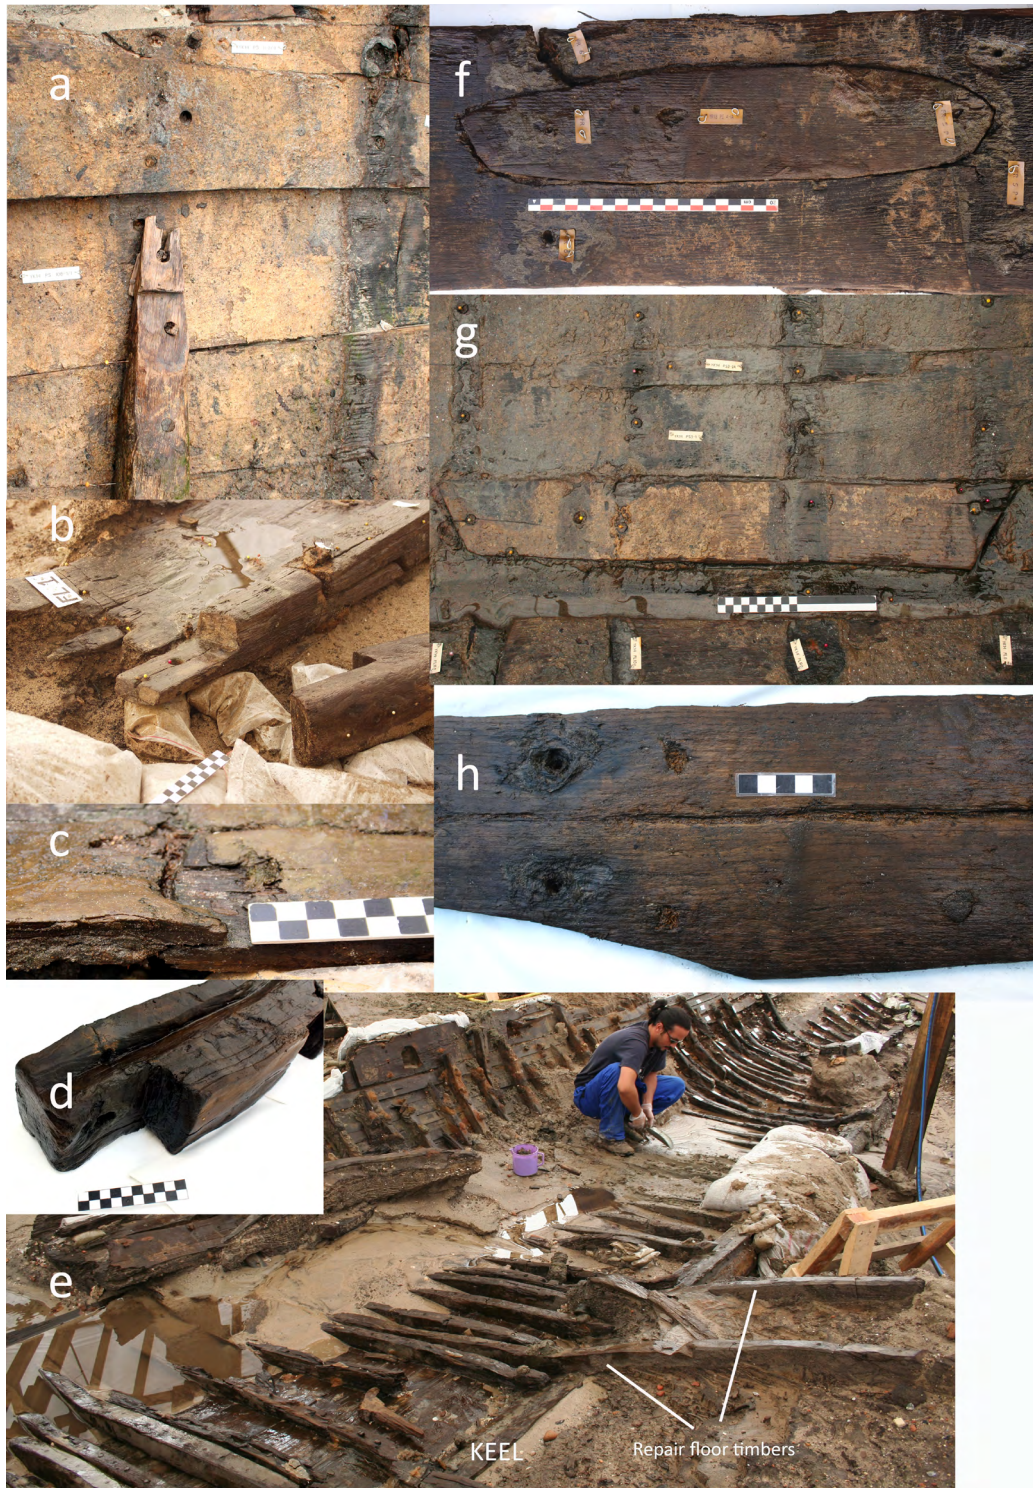
**Figure 12.4.** Examples of repairs from the Yenikapı shipwrecks: (a) Floor timber FL 44 from YK 14's hull. Note the caulked drilled holes next to the frame's location, which may be from an original frame, now removed; the timber's unique cross section and hook scarf are different from other frames on the ship. M. Jones, INA. (b) YK 24 Keel 3 timber, with the scarf for an endpost, Keel 4, which likely replaced more complex keyed hook scarfs normally used to join keel timbers. M. Jones, INA. (c) YK 14, PS 5-1A/5-2 scarf, at which an original plank piece was repaired with a worn, recycled timber. M. Jones, INA. (d) YK 11, end of the 'sternson,' recut from a keel timber (note the rabbet cut into the timber). R. Ingram, INA. (e) YK 4, replacement ash floor timbers in the midship area of the hull during excavation. M. Jones, INA. (f) YK 23, hull plank PS 4-1, with replacement piece PS 4-1A inserted in a rotten area (note the score mark and surface charring is missing on the repair piece). J. Čelebić, INA; (g) YK 14, replacement hull planks PS 2-1/1-2 and PS 3-1A, both recycled from a coak-built roundship similar to YK 14. M. Jones, INA. (h) A 'repair to a repair' (hull plank PS 6-2/1-4) from the hull of YK 14. A split in the plank (which was located at the turn of the bilge, and may have consequently been subject to more wear) was caulked. PS 6-2/1-4 was recycled from another ship (note the caulked treenail holes from its original use). The opposite end of the plank also had a repair piece installed into its scarf end (PS 6-2/5). Image by M. Jones, INA.

Repair evidence may be the result of single or multiple episodes. Sometimes it is clear that one repair was made before another: a 'repair to a repair' is present on at least one ship (strake PS 6 on YK 14) (Figure 12.4), and some repair timbers appear to be more worn than others. However, often the sequence cannot necessarily be established, or it is based on impressionistic evidence. Planking edge fasteners are useful for identifying hull planking repairs and recycling: when hull planks were

Floor timber (FL 44) may also be a repair, based on its trapezoidal cross section (different from the other frames) and a hook scarf on its end for an in-line futtock, a unique feature on the ship. A series of plugged drilled holes were found in the hull planking under this frame, indicating it was either replaced or was perhaps shifted slightly during construction (Figure 12.4a).

YK 14 was repaired almost entirely with recycled hull planks from a vessel built using similar methods (oak planking edge-fastened with coaks), besides extensive recaulking and application of pitch for waterproofing (Figures 12.4c, 12.4g, 12.4h). It was likely used for at least several years. It is unclear whether the repairs were installed in a single episode or multiple episodes, but the latter possibility seems more likely, based on the nature of the repairs. Low-quality or unseasoned timber may have required such maintenance within a shorter time (Liphshitz and Pulak 2010: 179; Belasus and Daly 2022: 213)

Although the hull's study is ongoing, YK 23 was clearly an old ship when it sank: over 20 repair planks and at least two probable repair planks have been identified (Figure 12.4f), in addition to at least one probable repair futtock at the turn of the bilge (F 15); rotten and shipworm-damaged

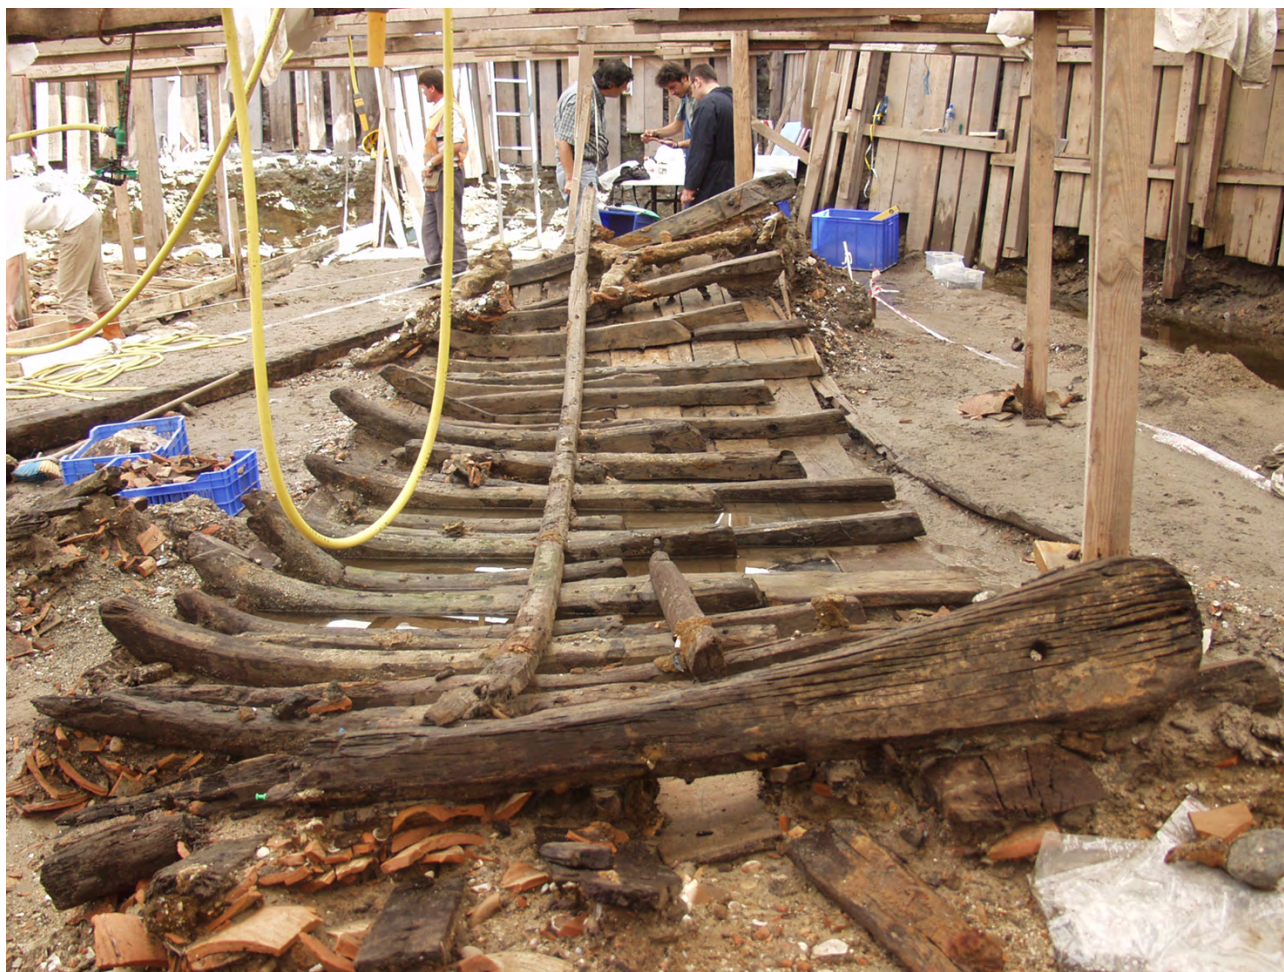
**Figure 12.5.** View of the preserved starboard side of YK 1, including strakes added during the overhaul of the ship, to the right. Copyright INA.

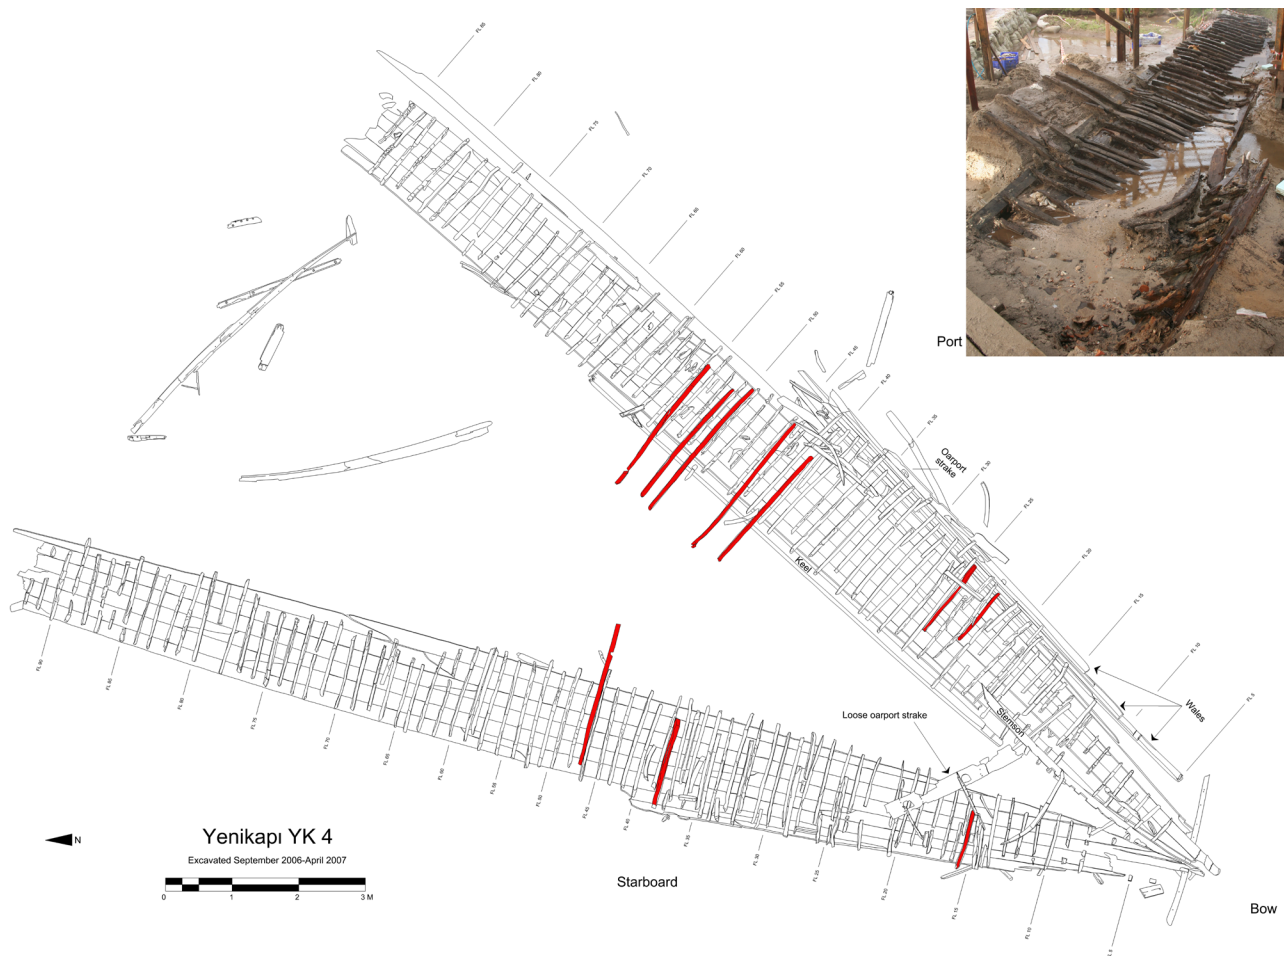
Figure 12.6. Site plan of YK 4, with identified repair frames shaded. Image by S. Matthews, INA; adapted by M. Jones.
