## New ideas about an old ship: some thoughts on the construction features of the late sixteenth-century *Scheurrak SO1* shipwreck

Hendrik Lettany

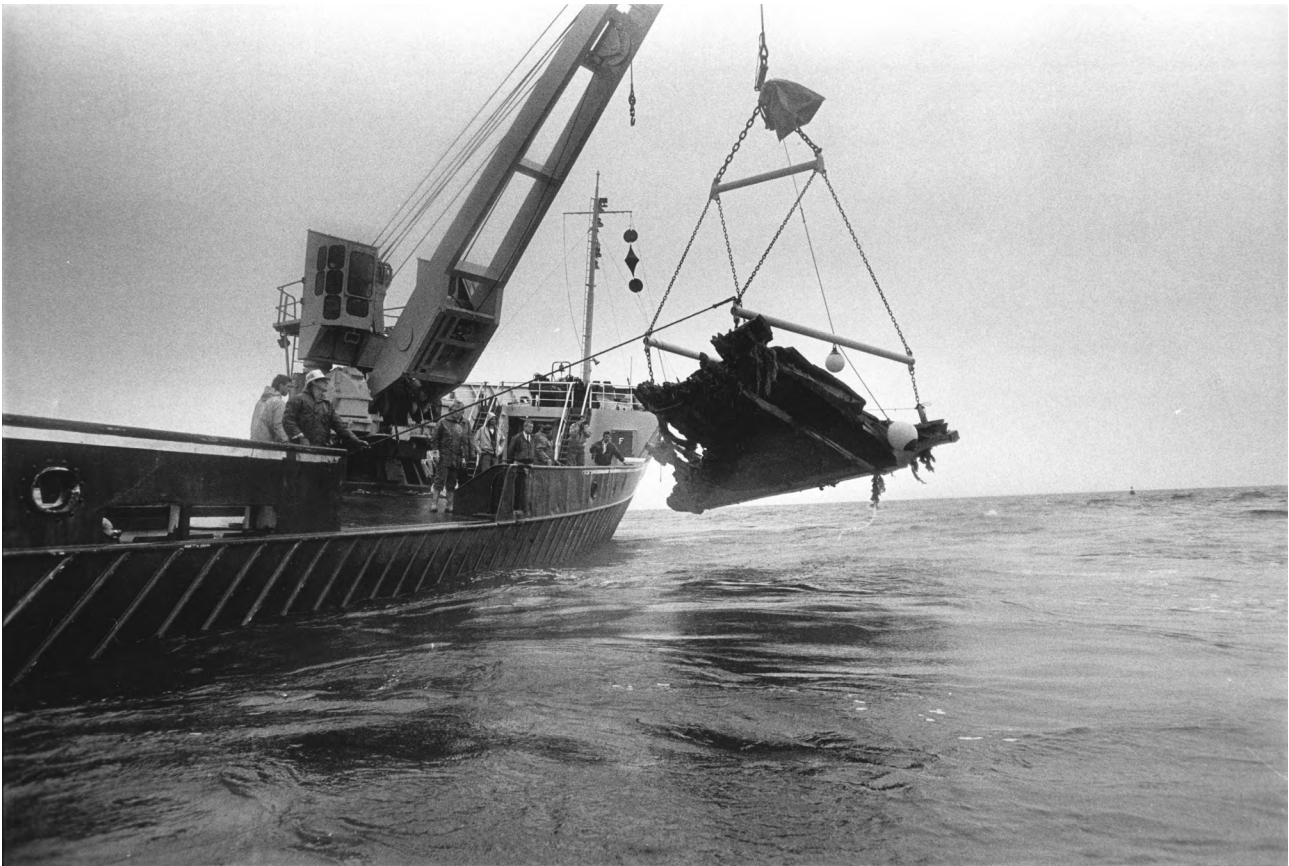
Figure 11.1. Lifting of the forward end of *Scheurrak SO1*'s lower hull. Copyright Rijksdienst Cultureel Erfgoed.

At the end of the 1988 field season, the forward end of the lower hull was sawn off and lifted for an in-depth analysis on land (Figure 11.1). The structure was transported to the city of Alphen aan den Rijn, where it was registered and described. In order to understand the relation between the different structural elements, the assemblage was dismantled in a systematic way. First the riders and ceiling planks were removed, then the keelson and next the frames. Finally, the two layers of hull planking were removed. A first analysis of the construction was mainly executed by intern Ronald Koopman, naval engineering student at the Hogeschool Rotterdam and Omstreken. His study resulted in a brief unpublished report (Koopman and Goudswaard 1991), as well as in several loose notes and drawings. These documents provide a useful source of information now, since most of the dismantled timbers were reburied afterwards on lot OZ40 in Zeewolde (Flevoland province), which is elaborated by the RCE as a ship (timber) graveyard. It is notable that not all timbers were reburied, probably only those which were fully examined and drawn by Koopman at that time.
