## Boats from bogs in Arctic Norway: depositional contexts and explanatory frameworks in the Late Iron Age and Mediaeval period

Stephen Wickler

**Abstract:** A comprehensive assessment of boat-related bog finds from the collection of the Arctic University Museum of Norway (Norges Arktiske Universitetsmuseum, NAU) materialises the entanglement of boat technology and cultural meaning in northern Norway during the Iron Age. Nineteen boat parts and related equipment made of Scots pine (*Pinus sylvestris*) from 17 bog locations have been documented. As the Early Iron Age and pre-Iron Age bog finds have been discussed in an earlier publication (Wickler 2019), this chapter focusses on bog boat finds from the Late Iron Age. The documentation of bog boats has emphasised absolute dating using radiocarbon and dendrochronology, in addition to detailed descriptions and graphic documentation of the objects. Some finds are related to ritual activities which include votive bog offerings and a boat grave. Most of the Late Iron Age boats have sewn planking, a construction technique which predates the use of iron rivets first documented in the Roman Iron Age and which is also associated with indige

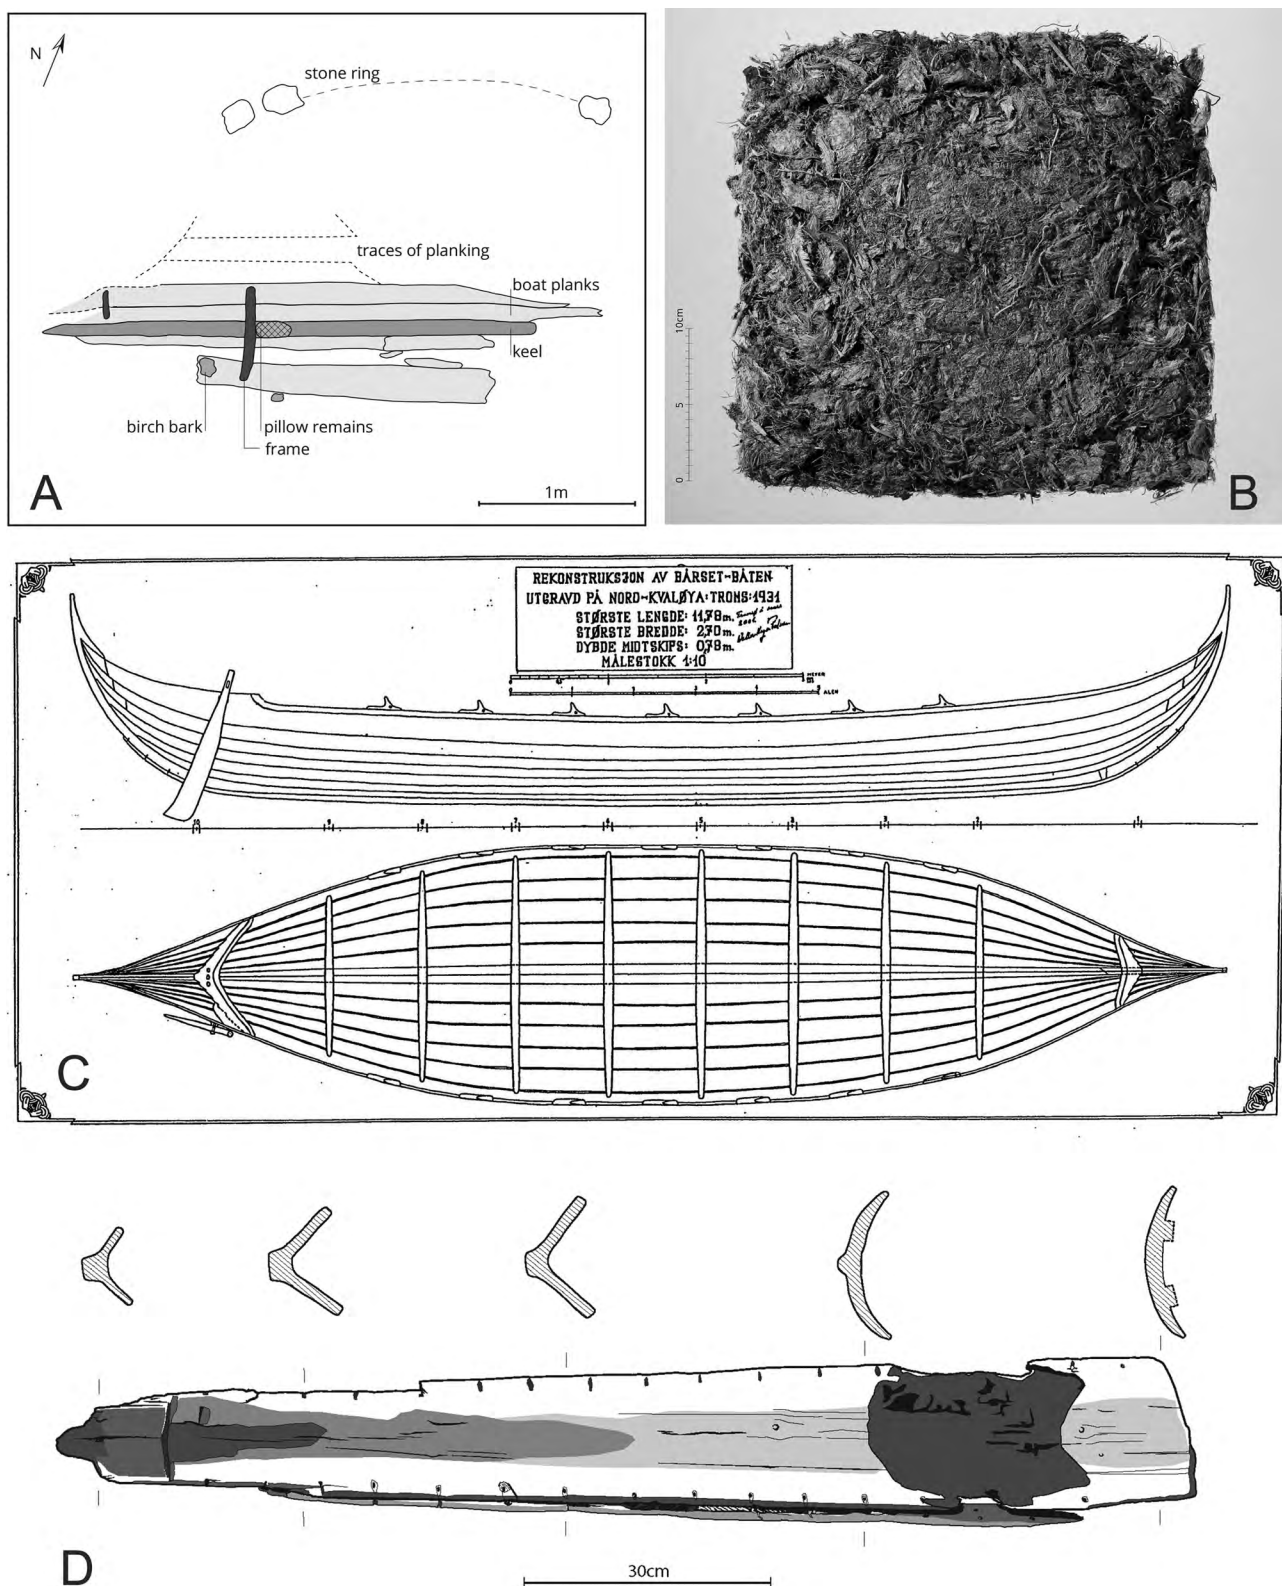
**Figure 9.2. Bog boats from ritual contexts: A) plan drawing of the Øksnes boat grave redrawn from Gjessing 1941, Fig. 31; B) feather pillow fill from Øksnes boat grave; C) drawing of 1931 Bårset boat reconstruction; D) top view of Rydningen boat keel with cross-section profiles. Illustrations: Arctic University Museum of Norway and used with permission.**

A 3.1 m section of the boat keel was preserved with a 5.0 cm long scarf for the fore stem on one side. There were no treenail holes for fastening the garboard strake, but a set of eight large treenail holes were placed along the centre of the keel about 10.0–48.0 cm apart, presumably for fastening frames. A single displaced frame fragment with an 8.5 × 4.5 cm profile was found with deep notches for planks and fragments of treenails for fastening the garboard strake. The remains of three strakes on the port side and two on the starboard side were also preserved. Long strands of twisted-wool caulking from additional

The following description of the Bårset boat construction focusses on fastening techniques which are relevant for its comparison with other bog boat finds. The frames are *c.* 90.0 cm apart and lashed to raised cleats on the strakes through single holes. The planks are thin (1.5–2.5 cm) with widths ranging from 22.0 to 29.0 cm. Apart from the top two strakes, the boat planks are fastened to one another and to the keel with rivets and caulked with long strands of twisted wool, not hemp rope as claimed by Gjessing (1941: 36). The two upper strakes are fastened together with a combination of stitches and treenails, although rivets are present near the fore and aft stems. The stitches are sewn with plant fibres, potentially from tree roots, between paired holes set at an angle and spaced 1.0–2.0 cm apart (Figure 9.3B). The interval between the stitches/

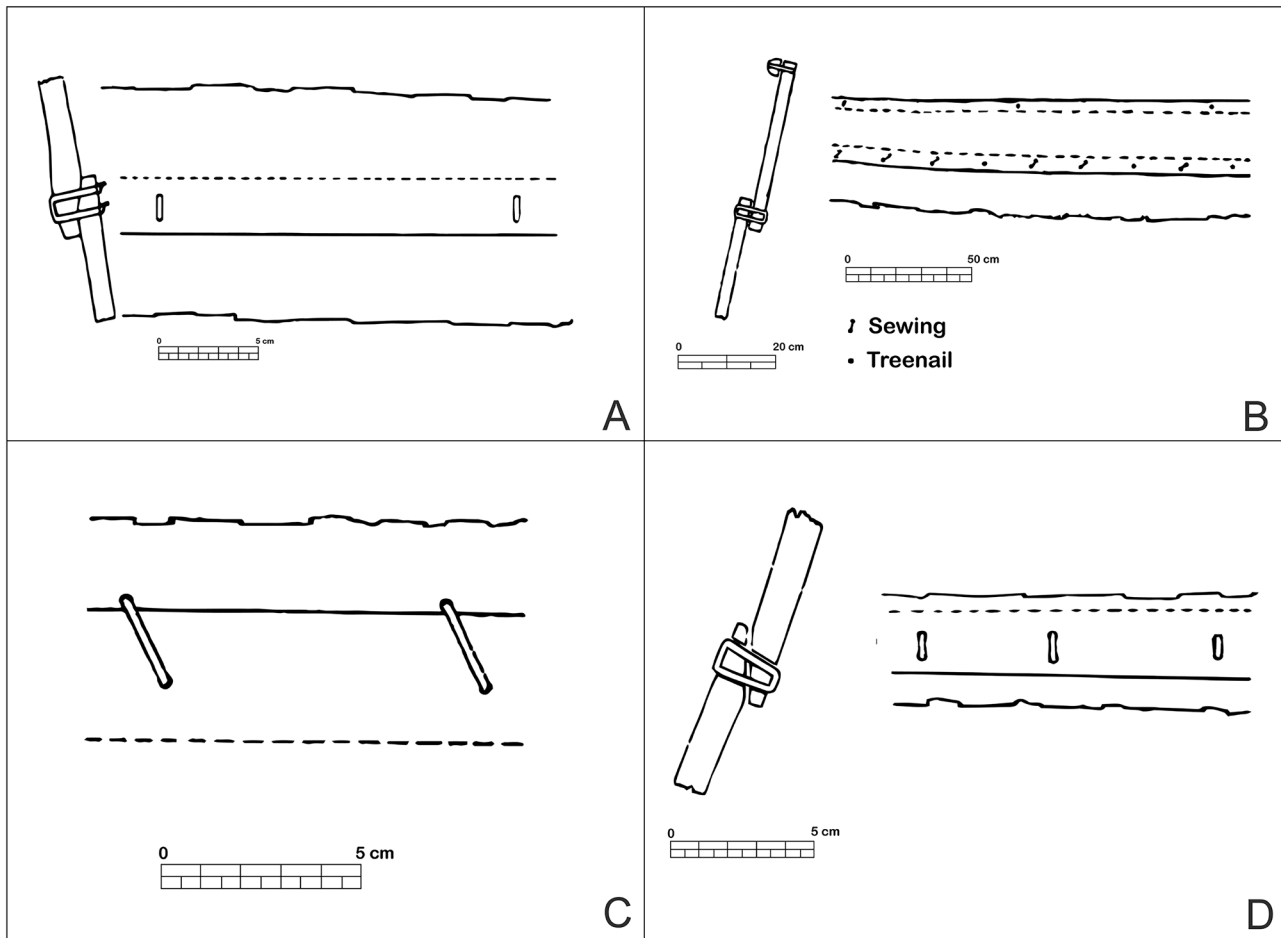
**Figure 9.3.** Boat stitching seams: A) Øksnes boat plank stitching seam; B) stitching and treenails fastening the upper two strakes on the Bårset boat; C) continuous stitching fastening keel to bottom plank on the Rydningen boat; D) plank stitching seam on the Halsnøy boat. Redrawn from Prins 1986: Figs. 9, 11, 12 and 14 with permission from H. H. T. Prins.

treenails varies 18.0–22.0 cm, although distances of 11.0 cm and 13.0 cm also occur. The gunwale is attached to the interior of the sheerstrake with treenails.

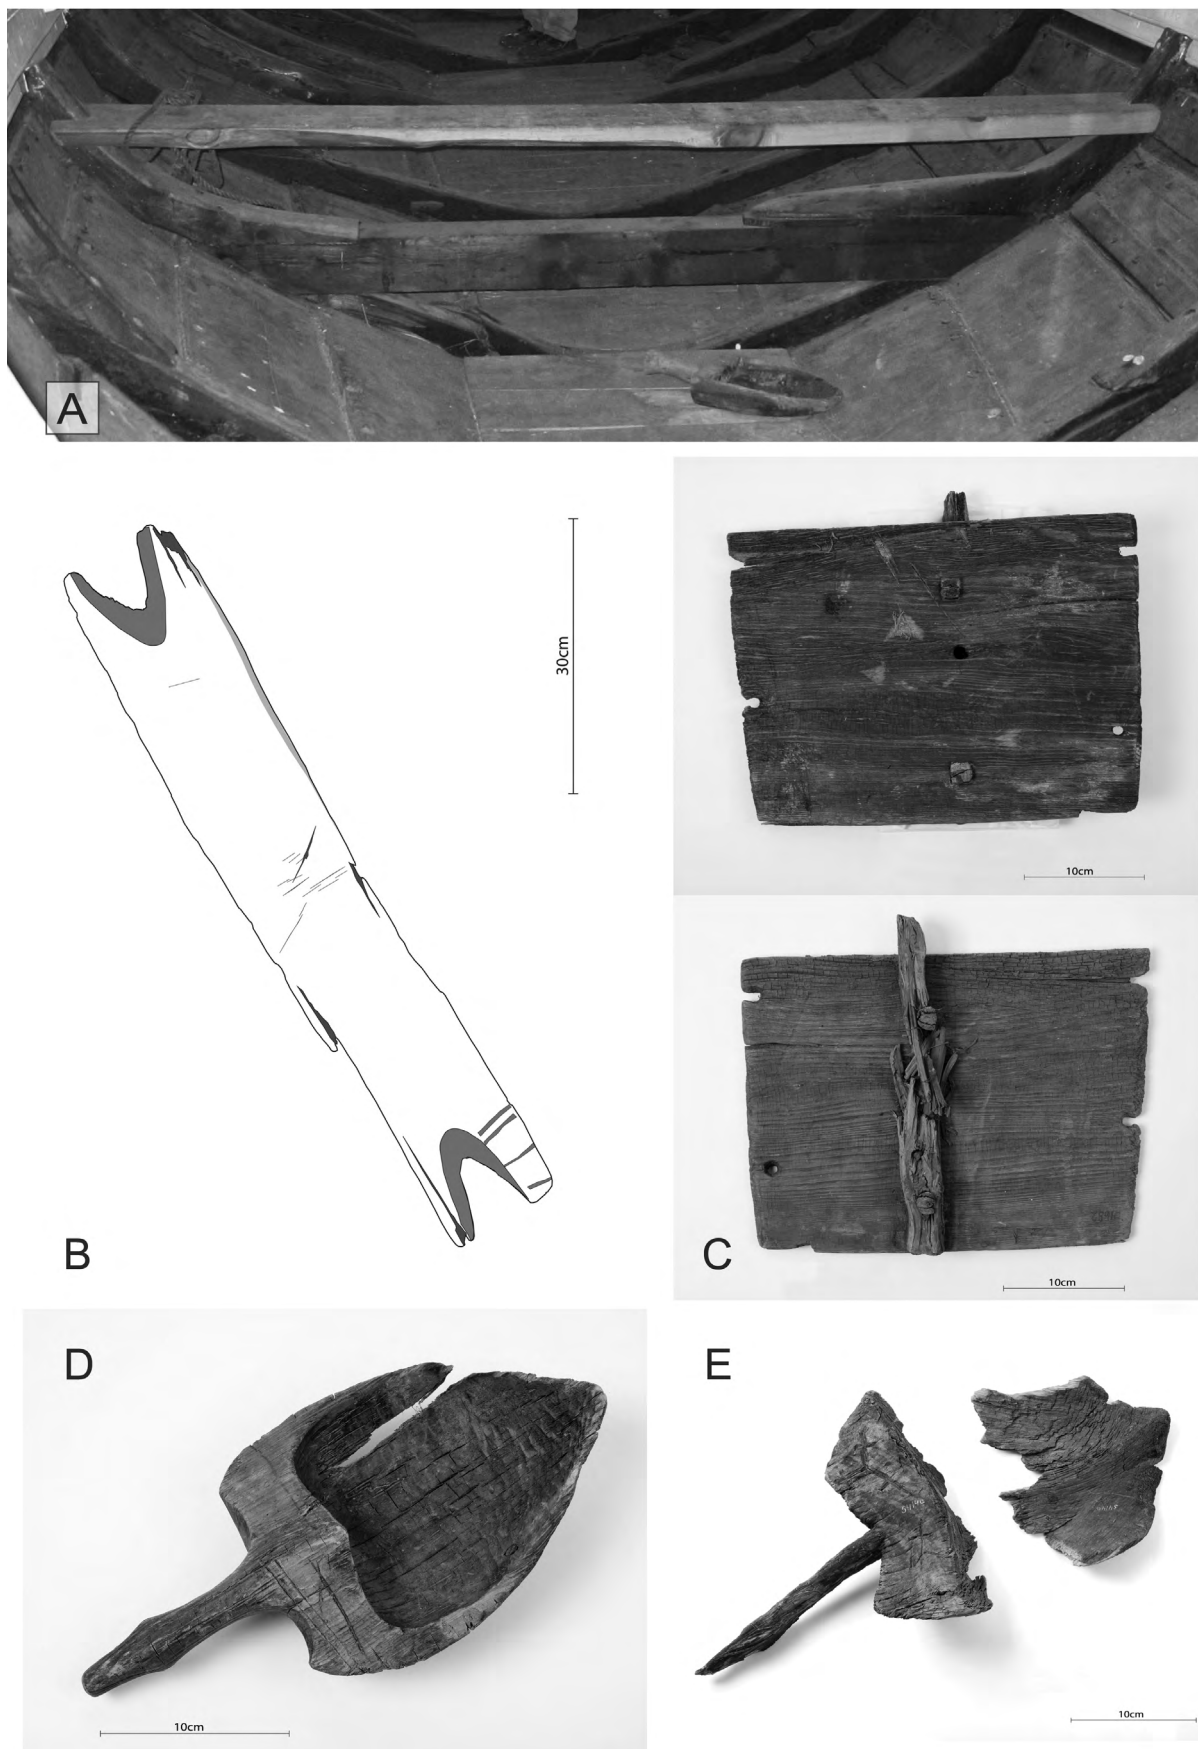
**Figure 9.5. Miscellaneous boat items: A) traditional Norwegian clinker-built rowboat with a thwart, floorboards and bailer; B) underside of thwart from Bøtnes with beveled end notches and cut marks in the midsection; C) flooring board from Andenes viewed from top and bottom; D) boat bailer from Andenes; E) boat bailer from Myre settlement mound in Vesterålen. Photo A from Wikimedia Commons distributed under a Creative Commons license; Photos B–E by Adnan Icaigic, Arctic University Museum of Norway and used with permission.**

Some boat parts and boat-related objects are relatively small and not fastened down in the boat. These include thwarts placed on frames and floorboards on the bottom of the hull which can be removed easily. Bailers are also essential boat gear. These items are not commonly associated with archaeological boat finds, and their presence in bogs provides a rare opportunity to explore continuity and change in essential items still commonly used in traditional Norwegian clinker-built boats (Figure 9.5A).

In 1939, a rowing oar blade and a thwart were found about 1 m deep in a bog near the shoreline at Bøtnes on the island of Grøtøya along the outer coast of northern Troms. The finds have been mentioned in several earlier publications (*e.g.* Gjessing 1941: 61–62; Bratrein 1989: 148). The oar blade has been radiocarbon dated to 772–895 cal AD, and although Gjessing (1941: 62) identified it as a steering oar, it is an example of standardisation in rowing oar blade form during the Viking Age (Wickler 2019: 199). The thwart is made of radially cut pine and has been radiocarbon dated to the Merovingian Period (534–640 cal AD). It is 89.0 cm long, 15.0 cm wide and 2.0–2.5 cm thick, with a sub-rectangular cross-section and 8.0 cm end notches with 2.0–5.0 cm bevels on the underside to fit a frame (Figure 9.5B).

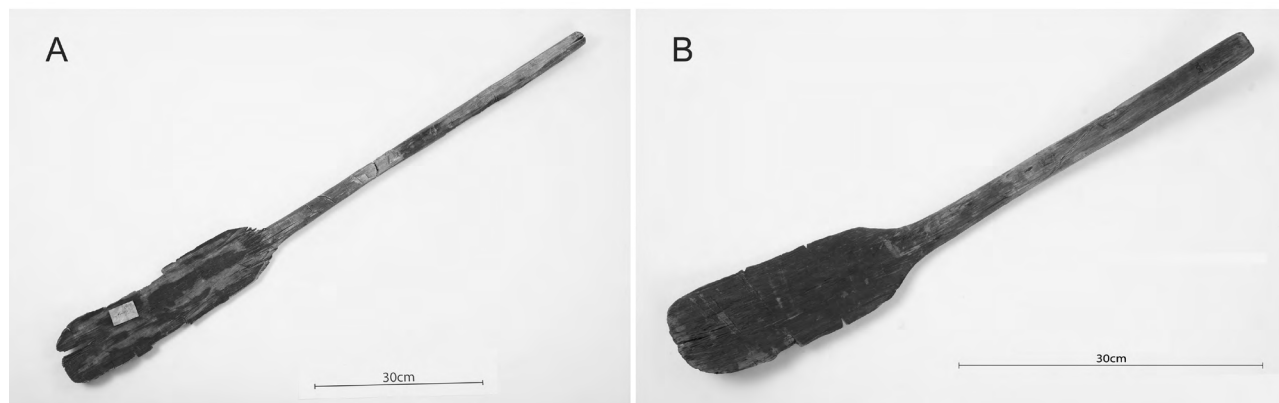
**Figure 9.6. Spades found in bogs: A) Andenes, Andøya; B) Sneisa, Lødingen. Photos by Adnan Icacig, Arctic University Museum of Norway and used with permission.**

Two spades were found at the bottom of bogs. They were most likely made of willow (*Salix caprea*), although botanical identification cannot rule out aspen (*Populus tremula*). Although originally identified as paddles, the tree species used, general appearance and blade shape make this assignment unlikely. The spades are both radiocarbon dated to the high Mediaeval period, while the most recent pre-modern paddle known from northern Norway is dated to the second millennium BC (Wickler 2019: 190–191). Historically, willow wood (Norwegian *selja*) was used for skis, rake handles and other utilitarian objects, but are not for paddles. The spades are similar to each other in appearance, and both were made from tree trunks with the heartwood centrally placed. The larger of the two spades was found in 1906 at the base of a bog about 2.0 m below the surface in the vicinity of Andenes on Andøya Island, and it has been radiocarbon dated to 1300–1370 cal AD. It is complete, with a total length of 114.0 cm and a 43.0 × 12.0 cm blade (Figure 9.6A). The second spade was found in 1886 below a bog deposit at a depth of 81.0 cm at Sneisa, Lødingen. It is 67.0 cm long with a 23.5 × 10.0 cm blade and an incomplete handle 39.0 cm long (Figure 9.6B).
